## รายงานวิจัยฉบับสมบูรณ์

โครงการการตรวจสอบและเตรียมความพร้อมโรงพยาบาลใน  
พื้นที่เสี่ยงภัยแผ่นดินไหว: บทเรียนจากแผ่นดินไหวแม่ลาว

โดย...ธีรพันธ์ อรรถธรรมรัตน์

มหาวิทยาลัยมหิดล

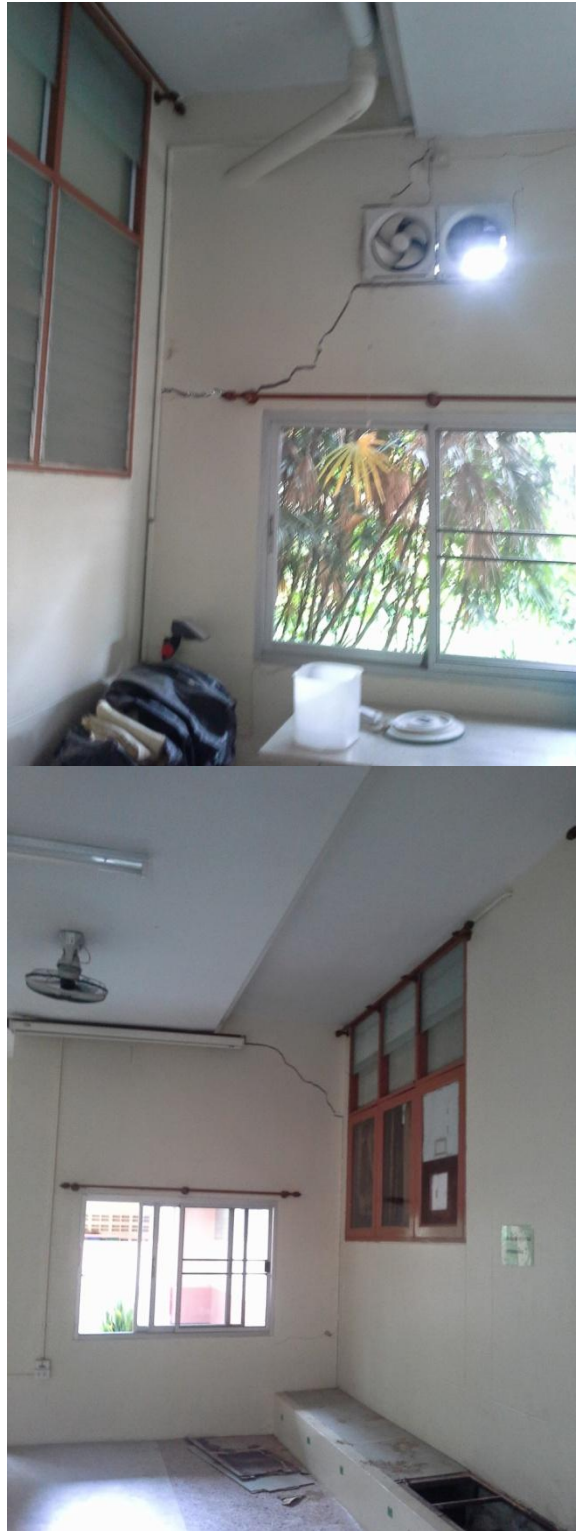
รูปที่ 1. Observed cracks on infill wall if the ground shaking was larger this wall would collapse inside the buildings.

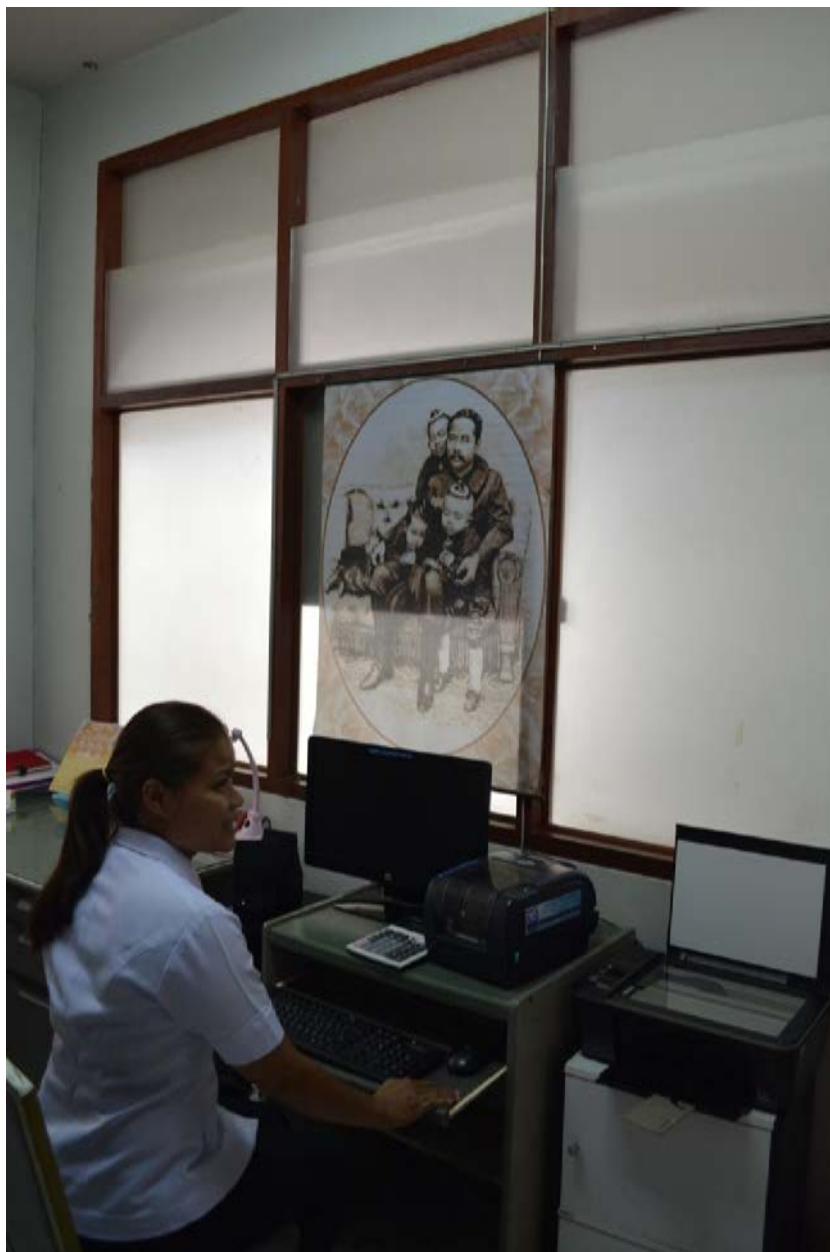
รูปที่ 3. ความปลอดภัยระดับ Life safety level จะเกิดขึ้นได้ถ้ามีการปรับปรุงกระจก  
โดยรอบสถานพยาบาล

| ระดับความปลอดภัยที่เกิดขึ้นหากมีการปรับปรุง | จำนวนที่พบ | วิธีการแก้ไข |
|---|---|---|
| Life Safety Level | มาก | ย้ายเตียงผู้ป่วยและที่ทำงานให้ห่างจากหน้าต่าง และ ทำการติดฟิล์มนิรภัย |

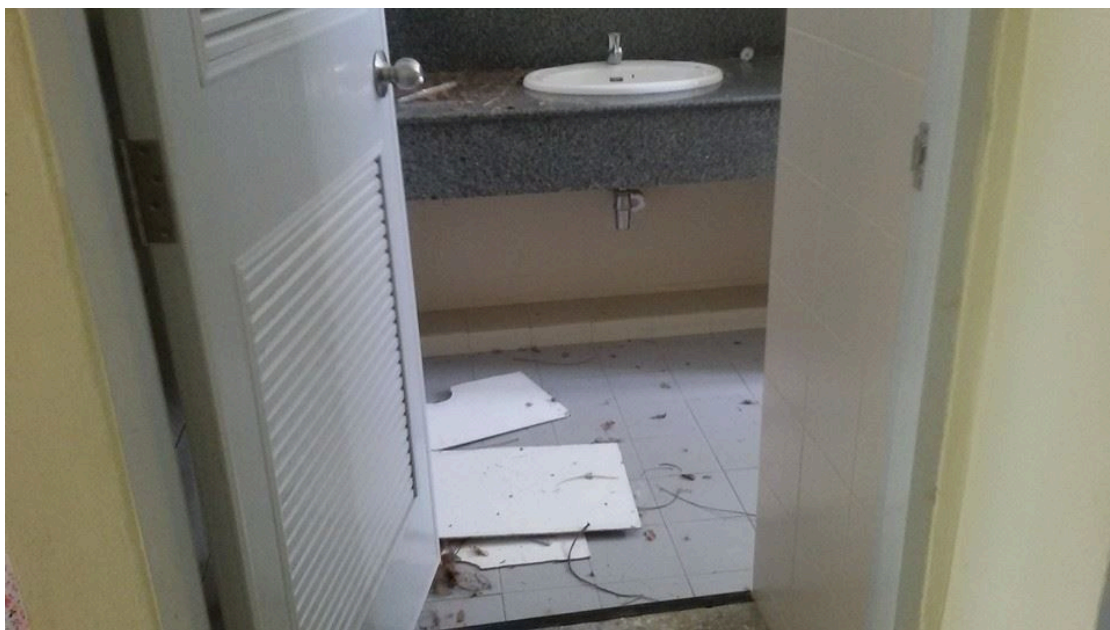
รูปที่ 4 การติดตั้งฝ้าเพดานโดยมีเหล็กตัว T และใช้หมุดยึดกับคานคอนกรีตเสริมเหล็ก  
ฝ้าเพดานร่วงหล่นลงมาบริเวณชั้นสองของอาคารแพทย์แผนไทย

| ระดับความปลอดภัยที่<br>เกิดขึ้นหากมีการปรับปรุง | จำนวนที่พบ | วิธีการแก้ไข |
|---|---|---|
| Immediate Occupancy<br>Level | มาก | บริเวณฝ้าเพดานที่กว้าง<br>มากกว่า 100 ตารางเมตร เช่น<br>ห้องประชุม ต้องทำการ<br>ปรับปรุงเสริมความแข็งแรง<br>ของฝ้าเพดาน |

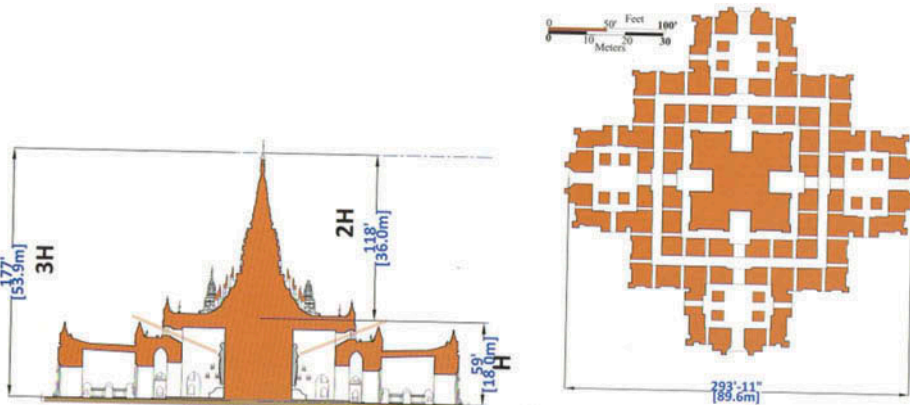
The Ananda temple (see Fig. 5) has a large, single-story temple with four vestibules and long corridors and is an example of a structure with moderate damage. It was first constructed in 1086 AD making it one of the oldest monuments in Bagan. The temple has symmetrical planes in horizontal and vertical directions. A large solid core, approximately 30 by 30 m, in the middle is responsible for the load bearing of the superstructure, which is about 51-m height. Observed damage was the damage of the top part of main bell and in one of the approach corridors from the temple's main entrance. Minimum damage has been observed in the main structure system. It is worth mentioning that similar a damage pattern has been observed from both 1975 and 2016 events.

**Figure 5.** Ananda temple cross-section and ground floor plan damages to Ananda temple.

intervention works of reinforced concrete corner ties installed after 1975 earthquake were intact and had worked very well noticeably.

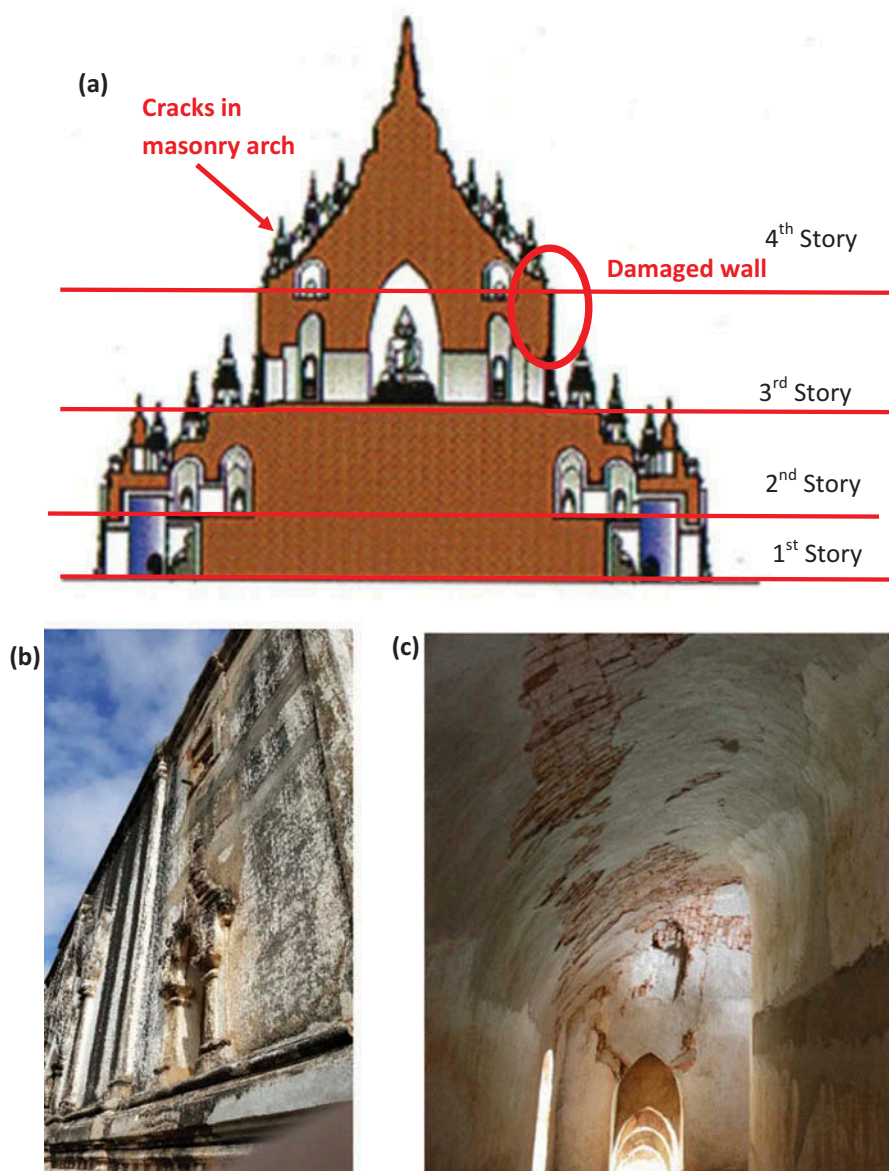
The other moderate damage is Thatbyinnyu temple, Fig. 6. It is a four-storied temple with a large solid core constructed in 1144 AD. The height of this temple is 61 m and is considered as the highest historical monument in Bagan. The solid core, approximately 44 by 44 m, is designed to bear the loads from the top structural part. All four sides of the walls at the base of the "Kundaung," the 3rd story, were slanted outward with large cracks. The arched halls below those walls were also damaged with peeling of plasters and stuccos and with large cracks at the crown of the arched roof. In some parts, a small portion of bricks on the roof were even pushed down about 5–7 cm. Similar damage patterns were also found in Dhammayangyi and Htilominlo temples. Toppled spire was found on the upper level of Htilominlo temple, causing additional damages to other parts. Its retrofitting during 1990s could be observed with a few numbers of longitudinal bars without lateral ties; however, it did not seem to be effective to prevent damage from future earthquake. Mostly, the structure at ground floor was basically unharmed. The

**Figure 6.** (a) Cross-section of Thatbyinnyu temple. Damages to Thatbyinnyu temple including, (b) observed wall damage in the third story due to high acceleration on top part, and (c) concentration of cracking at the central part of masonry arch in the fourth story.

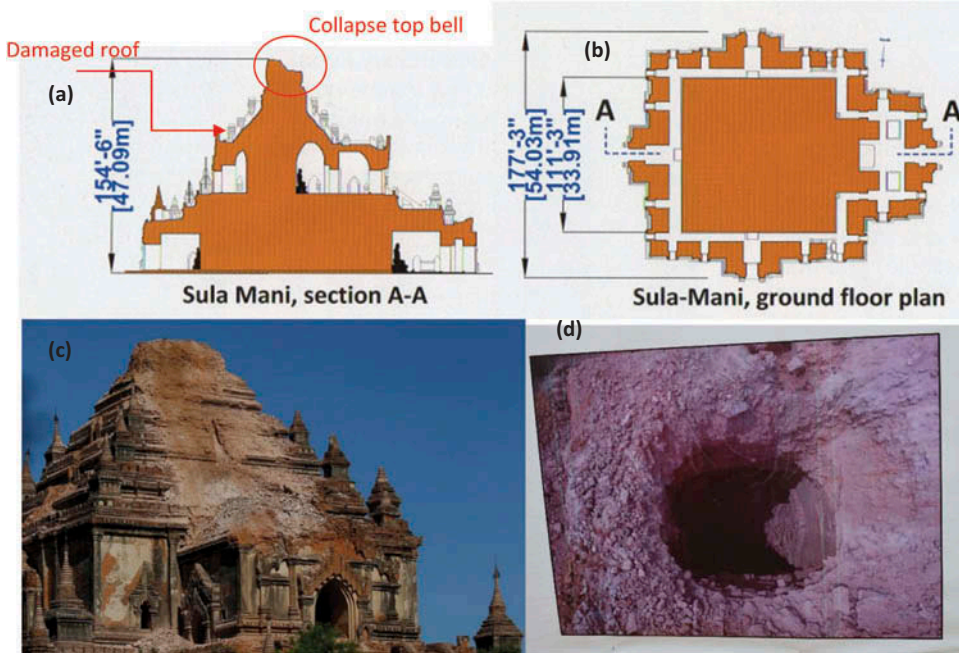
Among the visited ancient monuments, Sularmani is the most severely damaged one due to the collapse of the top bell and extensive damage to the roof in the second story, Fig. 7. Since the construction system of this structure was seen to be similar to that of Thatbyinnyu and Htilominlo Temples, the level of observed damage was surprisingly high. The difference between observed damage of these three temples might be due to the fact that the vertical irregularity of Sularmani temple, which differs from the more regular shape of Thatbyinnyu temple. Additional factor that might be able to explain the differences in observed damage is the

slenderness ratio of Sularmani Temple (height per width of solid core) is about 1.6 (55/34), which differs from the slenderness ratio of other monuments (e.g. 1.4 for Thatbyinnyu temple and 1.3 for Htilominlo temple). The collapse of the top part seems to have similar damage patterns as have been observed in the previous Mw 6.8 in 1975. Based on a local interview, the upper part “Kundaung” was reinstalled in 1990s with reinforced concrete and that upper part fell down on the roof of the upper terrace making a large hole at the top. The viewing stair and railing walls were also damaged significantly as a consequence. However, the base of the Pagoda

**Figure 7.** Damages to Sularmani pagoda including (a) Sularmani cross-section, (b) Sularmani ground floor plan, (c) collapse of top bell, and (d) severe damage to the eastern side roof at the second story due to falling of the top part. Soe Zeya Tun/Reuters.

and structure below the upper terrace were intact and strong despite the large impact of falling upper part. At the time of the reconnaissance survey, the team was not able to get inside only this temple due to the ongoing restoration operation.

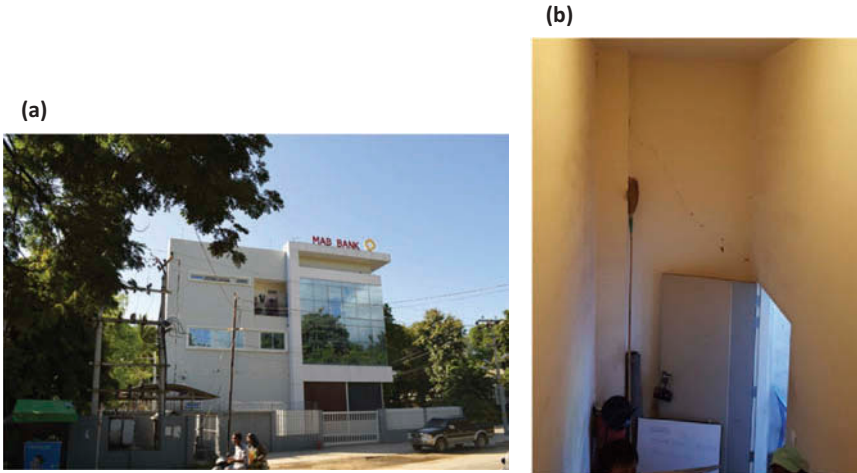
**Figure 8.** Light damage observed in reinforced concrete building in Chauk. (a) The vertical crack line occurred at the joint between main structure and concrete shaft causing pounding against each other during the earthquake and (b) observed in-plane shear cracking in URM infill. Depending on the wall geometry, in particular, the height/length aspect ratio, this URM infill is classified as flexural shear wall subjected to shear force and bending moment.

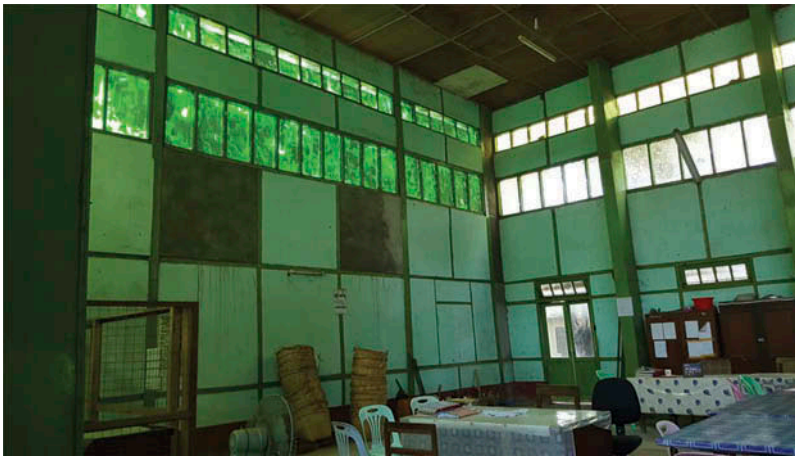
**Figure 9.** Timber frame with brick noggin is widely observed in Bagan and Chauk without any structural damage; however, nonstructural failures such as out-of-plane failure of brick wall and ceiling were observed in Chauk.

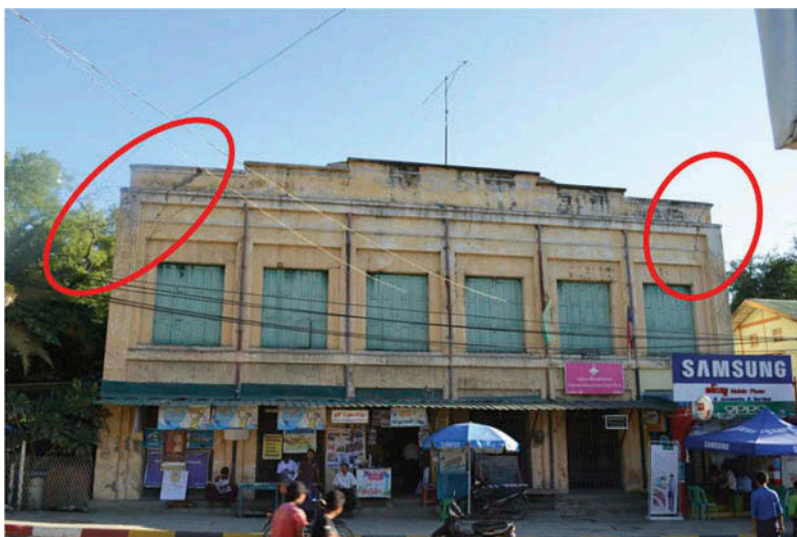
Brick load-bearing structural system is mostly built during British colony period. Most of them are two-story or less. In Chauk, only light damage could be observed to URM buildings. The most importantly observed damages for this kind of structure are the cracking developed in the main façade, namely around the first store windows and openings, and the extensive shear cracking in the second story, which indicated that the façade was in an initial stage of failure (Fig. 11). Very few observed damage for this kind of

**Figure 11.** Moderate damage to unreinforced brick masonry building built during British colony era. The extensive shear cracking in the second story indicated that the façade was in an initial stage of failure.
