## รายงานวิจัยฉบับสมบูรณ์

โครงการการกักกรองในสภาวะอุณหภูมิสูงระหว่างโลหะ  
เหลวที่บรรจุในท่อบรรจุเชื้อเพลิงสำหรับเครื่องปฏิกรณ์  
นิวเคลียร์แบบน้ำอัดความดันกับเหล็กกล้าไร้สนิมและ  
คอนกรีตมวลหนัก

**Project Title : High-Temperature Corrosion Behaviors between Liquid Metal as  
PWR Fuel Gap Filler and Stainless Steel and High-Density Concrete**

# High-temperature compatibility between liquid metal as PWR fuel gap filler and stainless steel and high-density concrete

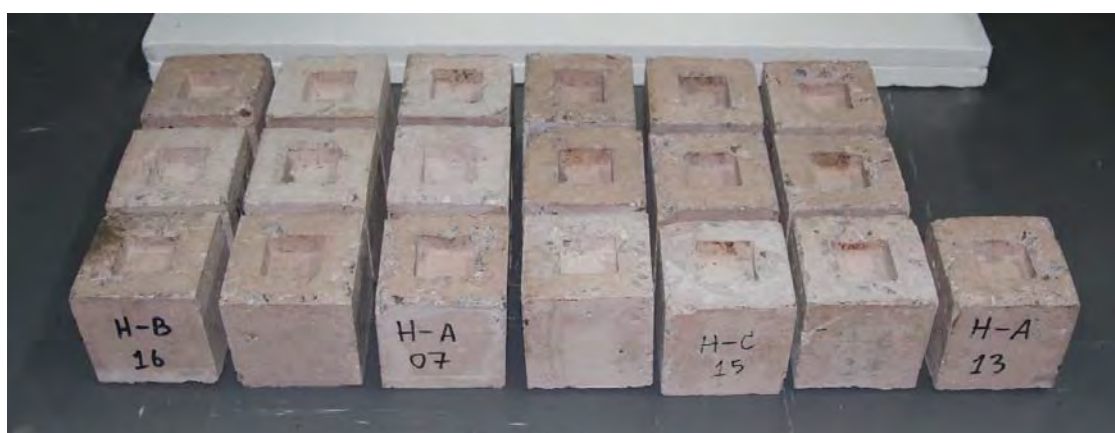
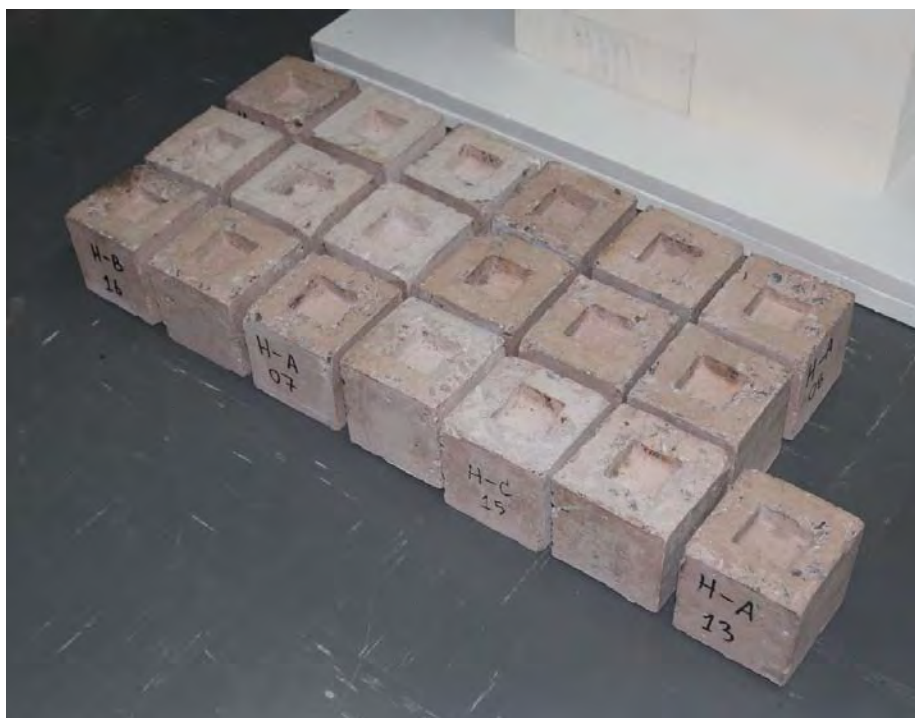
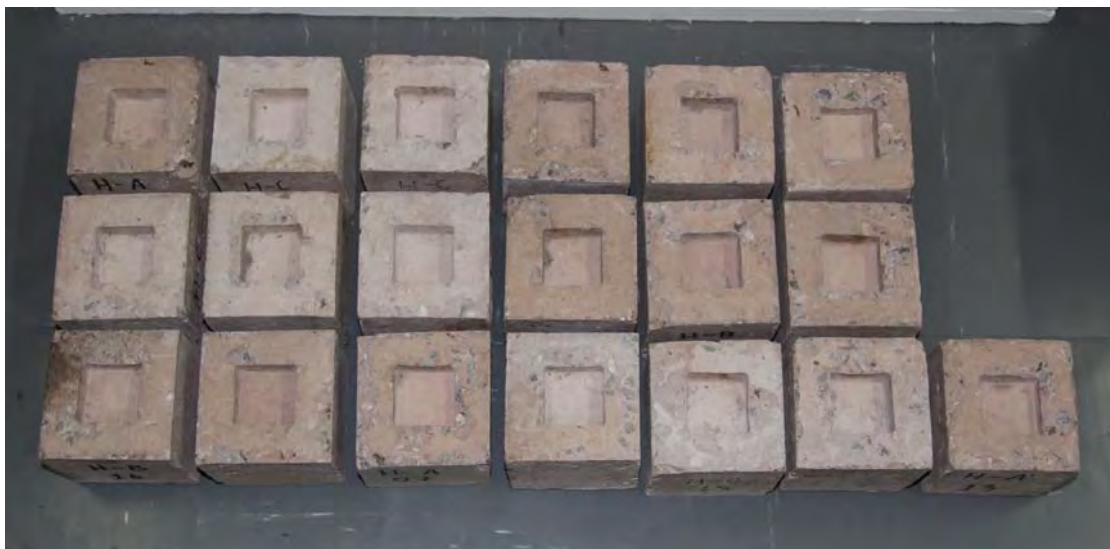
ได้ผลิต High-density concrete จำนวน 20 ชิ้นโดยใช้ Type-1 Portland cement แบริท์หยาบและแบริท์ละเอียดดังแสดงในรูปที่ 1(a) - 1(c) (ชั้นที่ 20 วางอยู่ใน Furnace) โดยแต่ละชิ้นผลิตเป็นรูปลูกเต๋ายาวขนาด 10 ซม. และมีเขี้ยวด้านบนลึกประมาณ 1 ซม. เพื่อให้สามารถบรรจุโลหะไว้ได้และเมื่อเวลาหลอมละลายจะได้ไม่ไหลออกมา High-density concrete นี้มีส่วนผสมของแร่ Barite จึงมีลักษณะสีชมพูอ่อนๆ ตามสีของแร่

**รูปที่ 1(a) - 1(c) High-density concrete ที่ผลิตได้**

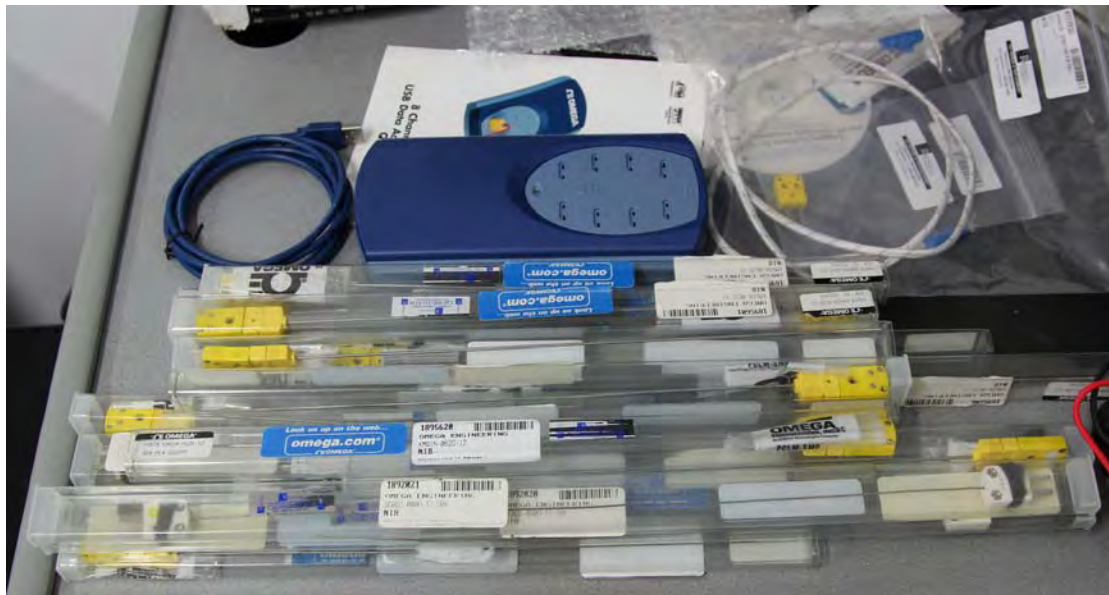
ได้ซื้อ Thermocouple โลหะสำหรับสร้าง Thermocouple junction และ 8-channel data acquisition board ดังแสดงในรูปที่ 2 (แต่จะไม่มีการใช้งานเพราะจะใช้ Infrared pyrometer แทน แต่ก็สามารถนำไปใช้ในงานวิจัยอื่นๆ ให้เกิดประโยชน์ได้มากมาย)

**รูปที่ 2 Thermocouple โลหะทำ Thermocouple junction และ 8-channel data acquisition board (ไม่ใช่ในงานนี้เพราะจะใช้ Infrared pyrometer แทน)**

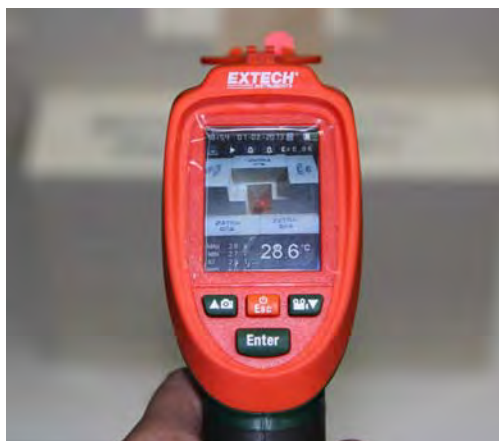
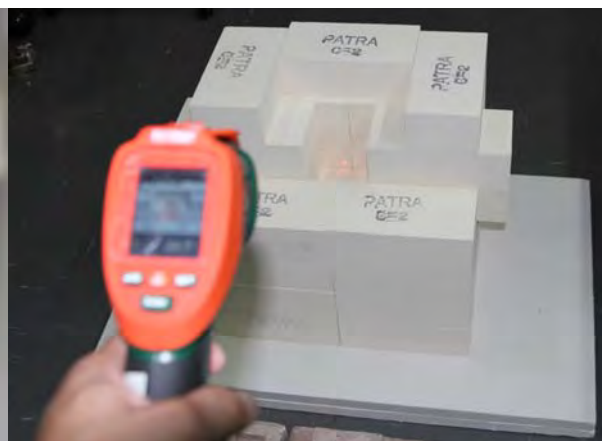
ได้ซื้อ Infrared pyrometer ซึ่งใช้งานได้ง่ายมาก โดยเล็งลำแสงเลเซอร์ไปยังจุดที่ต้องการวัดอุณหภูมิ ก็จะสามารถทราบอุณหภูมิได้ในทันที ดังแสดงในรูปที่ 3(a) - 3(b) (เนื่องจากเครื่องนี้จัดเป็นเป็นครุภัณฑ์ จึงใช้งบประมาณส่วนตัวในการจัดซื้อ และเครื่องนี้สามารถนำไปใช้ประโยชน์กับงานวิจัยอื่นให้เกิดประโยชน์ได้อีกมากมาย)

**รูปที่ 3(a) - 3(b) Infrared pyrometer ที่จะใช้วัดอุณหภูมิของโลหะเหลว**

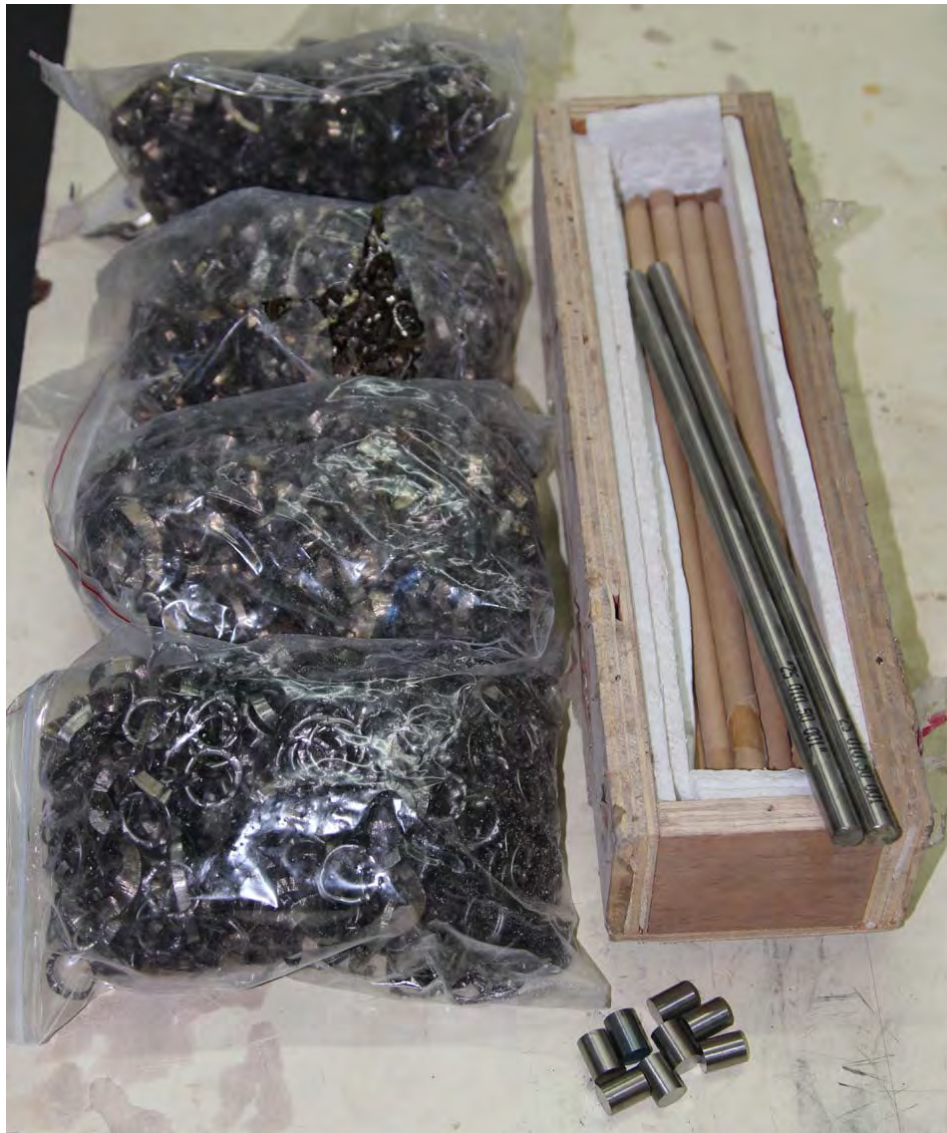
ได้ซื้อโลหะเซอร์โคเนียมแบบแท่งและแบบเศษเล็กๆ เพื่อที่จะสามารถปรับน้ำหนักที่จะใส่ใน High-density concrete block ได้อย่างแม่นยำ โดยบางส่วนของแท่งเซอร์โคเนียมได้ทำการตัดเป็นชิ้นเล็กๆ แล้ว เพื่อความสะดวกในการใส่ลงใน High-density concrete block ดังแสดงในรูปที่ 4 ส่วนโลหะเหล็ก มีปริมาณเพียงพออยู่ในห้องปฏิบัติการวิจัยแล้ว

รูปที่ 4 โลหะเซอร์โคเนียมแบบแท่งและแบบเศษเล็ก ๆ

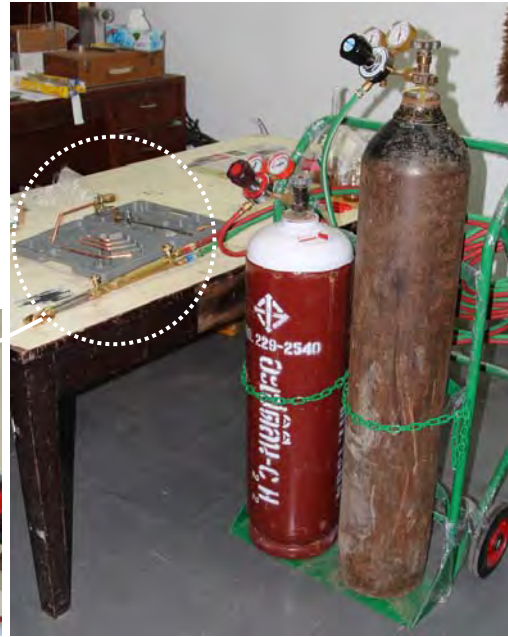
ได้ซื้อ Oxy-acetylene welding system ซึ่งประกอบด้วยถังก๊าซ Oxygen ถังก๊าซ Acetylene ตัว Regulator สำหรับแต่ละก๊าซ รถเข็นถังก๊าซ ท่อเชื่อมก๊าซ ตัวกันไฟไหลย้อนกลับ และชุดหัวตัด-เชื่อม-เผา ดังแสดงในรูปที่ 5(a) - 5(b)

รูปที่ 5(a) - 5(b) Oxy-acetylene welding system

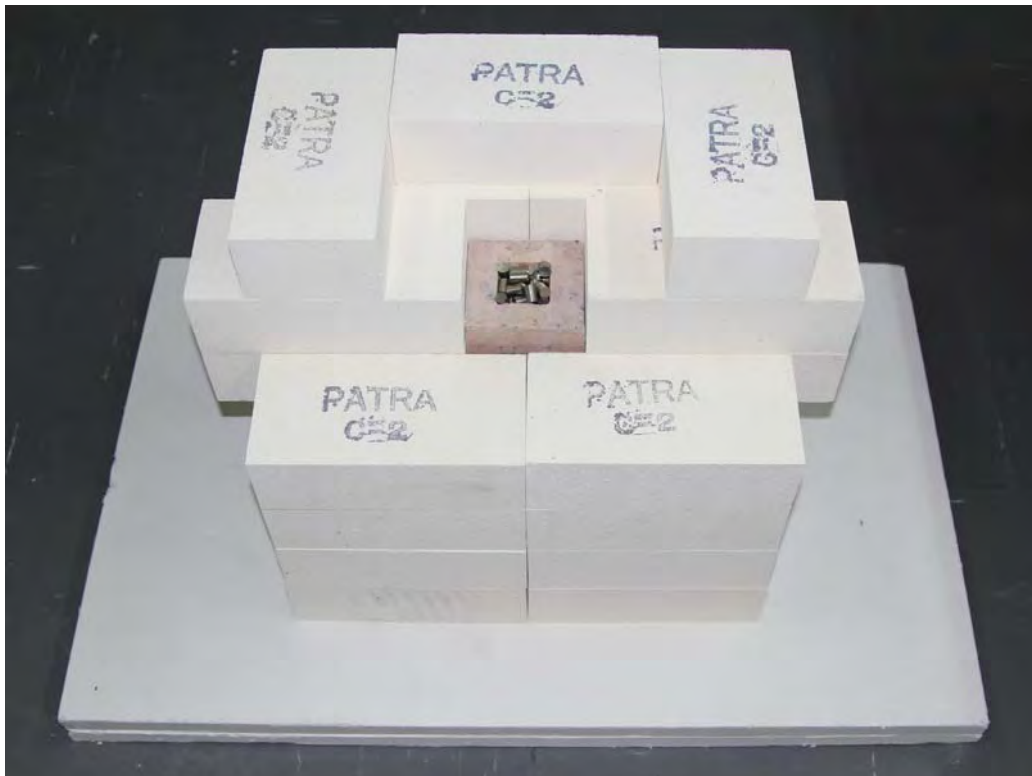
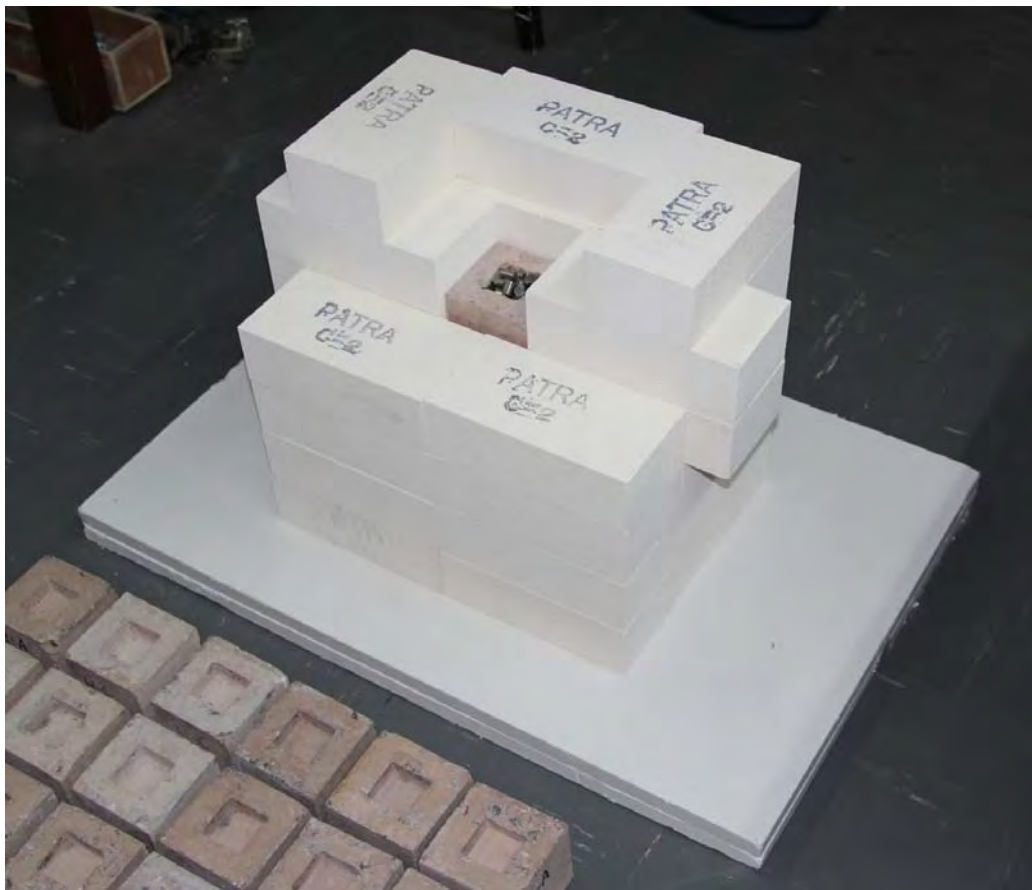
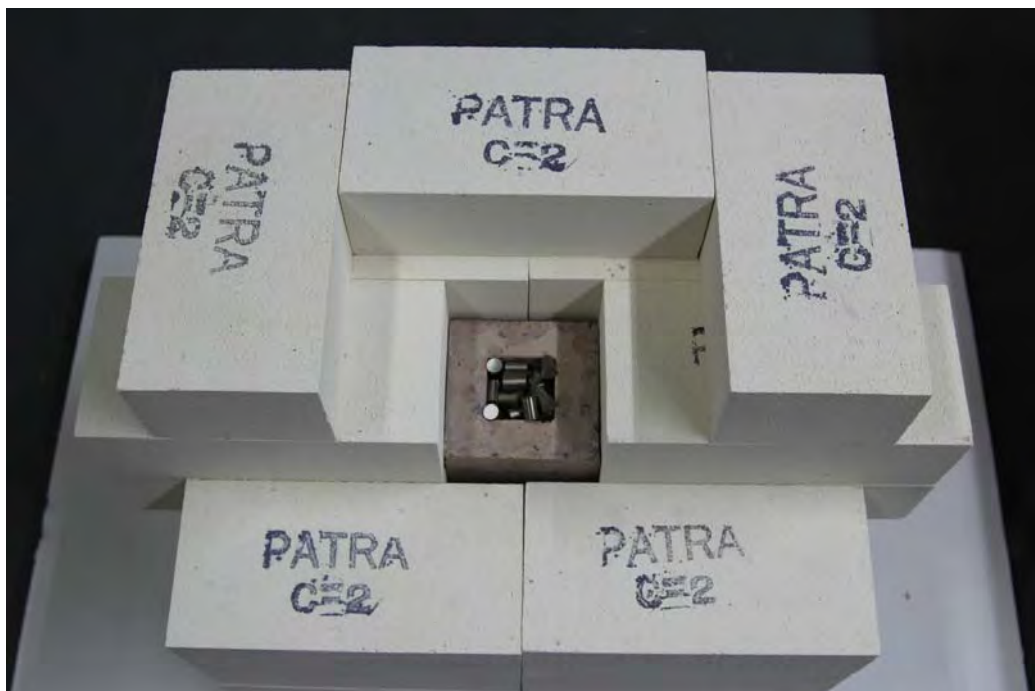
ได้สร้าง Furnace อย่างง่ายโดยด้านล่างสุดเป็นแผ่น Ceramic fiber 2 แผ่น ทนความร้อนได้  $1,400^{\circ}\text{C}$  และด้านบนเป็นอิฐทนความร้อนเรียงซ้อนกันหลายๆ ก้อนอย่างเหมาะสม ดังแสดงในรูปที่ 6(a) - 6(c) โดยอิฐแต่ละก้อนทนความร้อนได้  $1,200^{\circ}\text{C}$  ซึ่งหากเกิดความเสียหายขึ้นก็สามารถเปลี่ยนก้อนใหม่ใส่ได้อย่างง่ายดายเพราะมีน้ำหนักเบาและมีราคาถูก

รูปที่ 6(a) - 6(c) Furnace อย่างง่ายที่ได้สร้างขึ้น ตรงกลางบรรจุ High-density concrete ซึ่งมีแท่ง Zirconium สั้น ๆ บรรจุอยู่หลายแท่ง

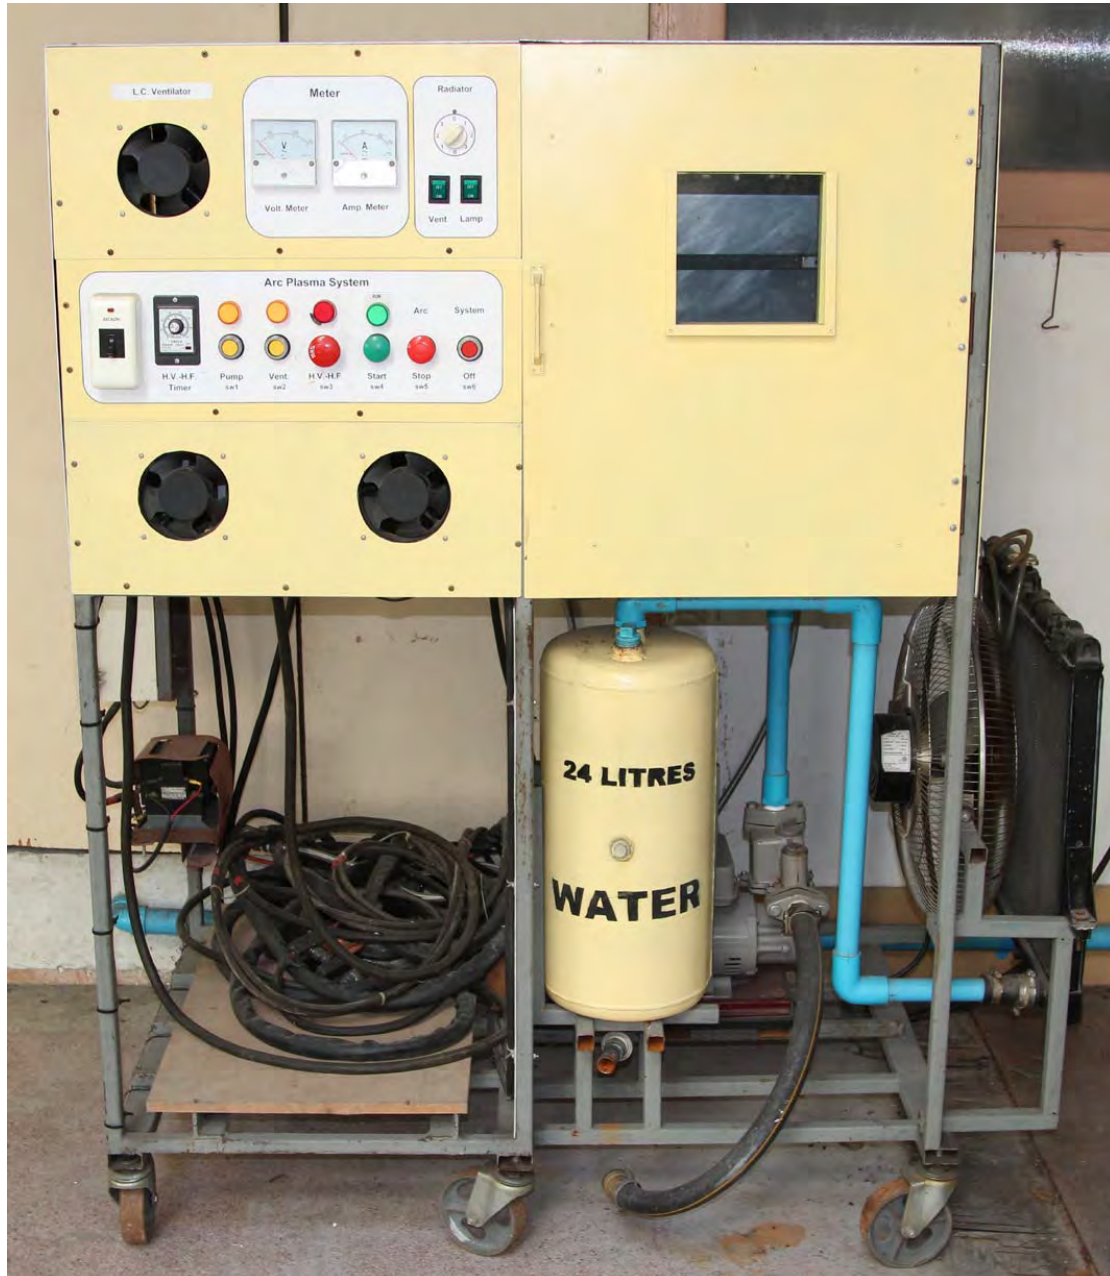
7(a) เครื่อง Arc plasma ที่ทดลองใช้หลอมโลหะ

ท้ายสุดแล้วได้ทดลองหลอมโลหะและเทลงใน High-density concrete block โดยใช้เครื่อง Arc plasma ที่มีในห้องปฏิบัติการวิจัย (ได้ดำเนินการทดลองนี้ก่อนที่จะซื้อ Oxy-acetylene welding system และสร้าง Furnace อย่างง่ายขึ้น) ซึ่งผลที่ได้เป็นที่น่าพอใจเพราะคอนกรีตไม่แตกออกเป็นเสี่ยงๆ และสามารถรักษาโลหะเหลวไว้ในเบ้าได้ ดังแสดงในรูปที่ 7(a) - 7(d)

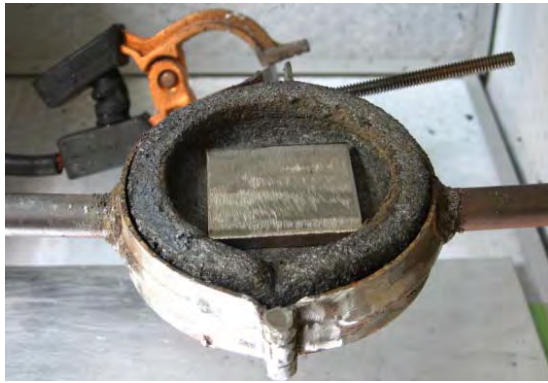
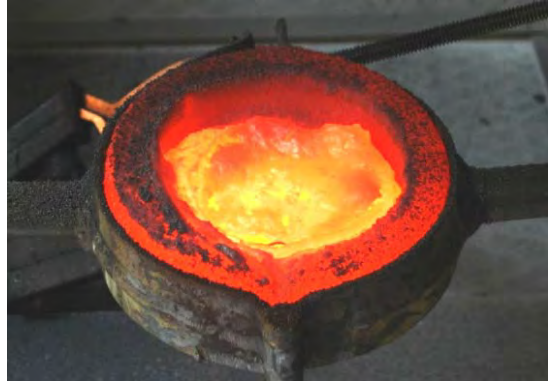
7(b) ตัวอย่างการหลอมโลหะเหล็กใน Graphite crucible

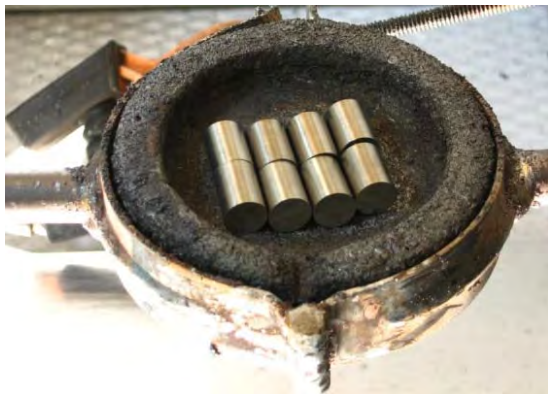
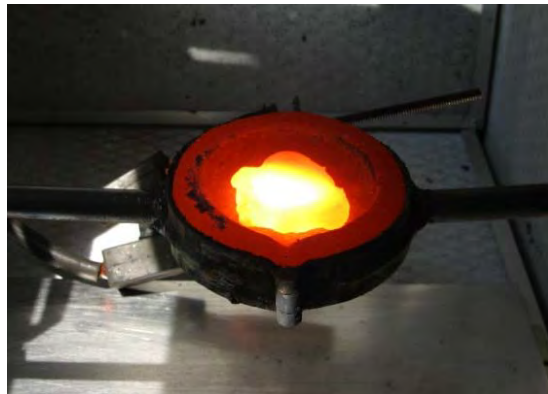
7(c) ตัวอย่างการหลอมโลหะเซอร์โคเนียมใน Graphite crucible

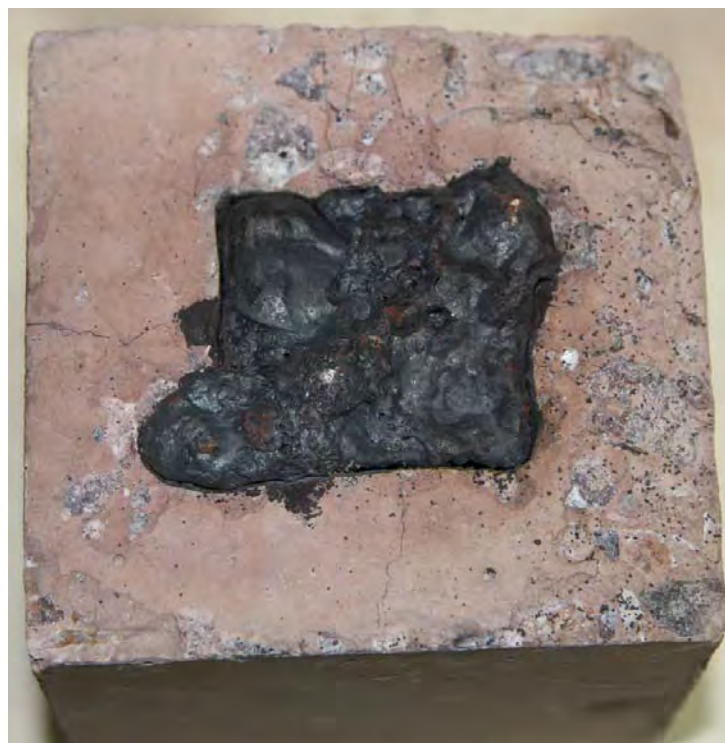
7(d) โลหะเหลวที่เทลงใน High-density concrete (ในรูปได้กลายเป็นของแข็งแล้ว)  
รูปที่ 7(a) - 7(d) การทดลองหลอมโลหะและเทลงใน High-density concrete โดยใช้  
เครื่อง Arc plasma

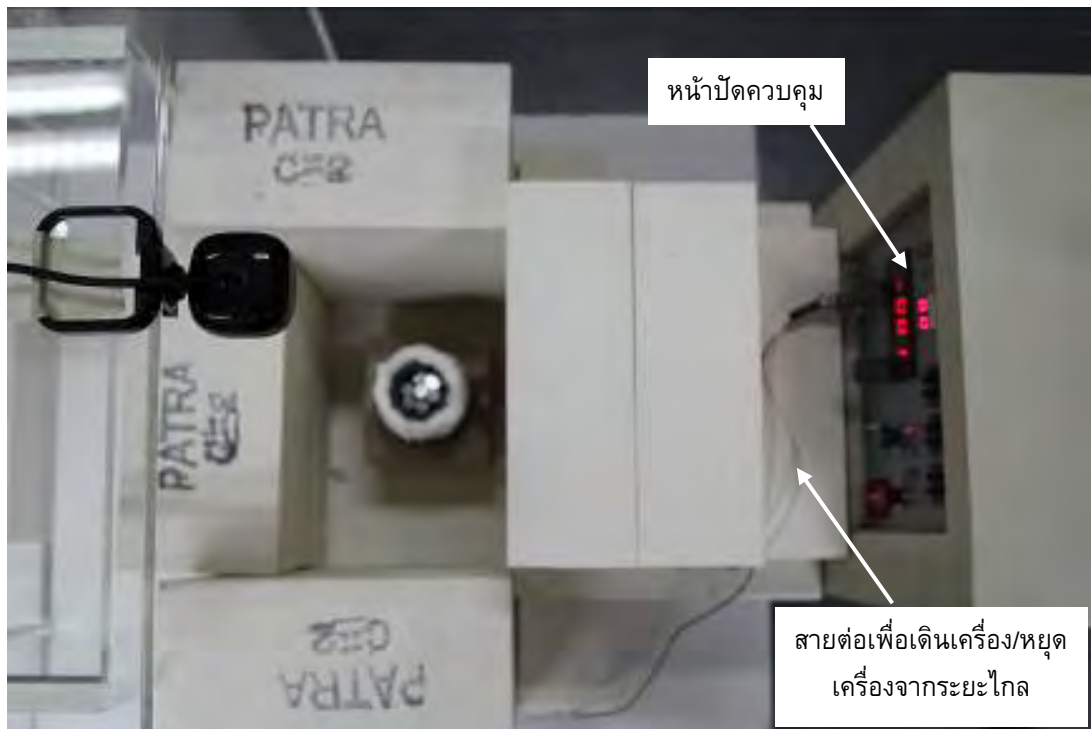
อย่างไรก็ตาม เมื่อพิจารณาอย่างถี่ถ้วนกับที่ปรึกษาแล้ว (รวมถึงได้ทำการปรึกษากับ Professor Donald Olander ศาสตราจารย์ในสหรัฐอเมริกาที่ผู้รับทุนทำวิจัยระดับปริญญาโท และเอกด้วย และเป็นผู้เชี่ยวชาญในด้านวัสดุนิวเคลียร์) ได้ข้อสรุปว่าใช้ Induction heater จะเหมาะสมที่สุด เพราะจะส่งพลังงานให้โลหะร้อนขึ้นแต่เพียงอย่างเดียว ไม่ส่งพลังงานโดยตรงให้คอนกรีตร้อนด้วย (คอนกรีตจะร้อนจากการสัมผัสกับโลหะที่ร้อน) ซึ่งก็เป็นสิ่งที่เกิดขึ้นจริงในกรณีเกิดอุบัติเหตุนี้ ผู้รับทุนจึงซื้อเครื่อง Induction heater ขนาด 35 kW โดยออกค่าใช้จ่ายเอง เพื่อนำมาใช้ในงานวิจัยนี้ รูปที่ 8(a) - 8(c) แสดงการจัดวางสิ่งต่างๆ ในการทดลองใหม่นี้

รูปที่ 8(a) - 8(c) การจัดวางสิ่งต่าง ๆ ในการทดลอง

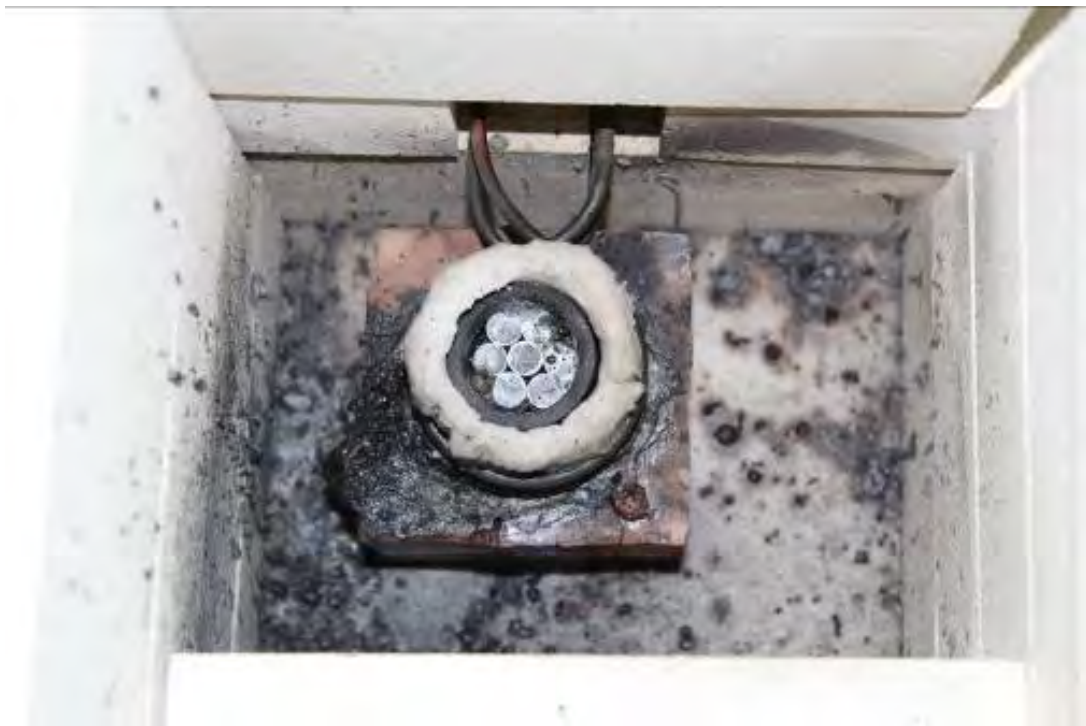
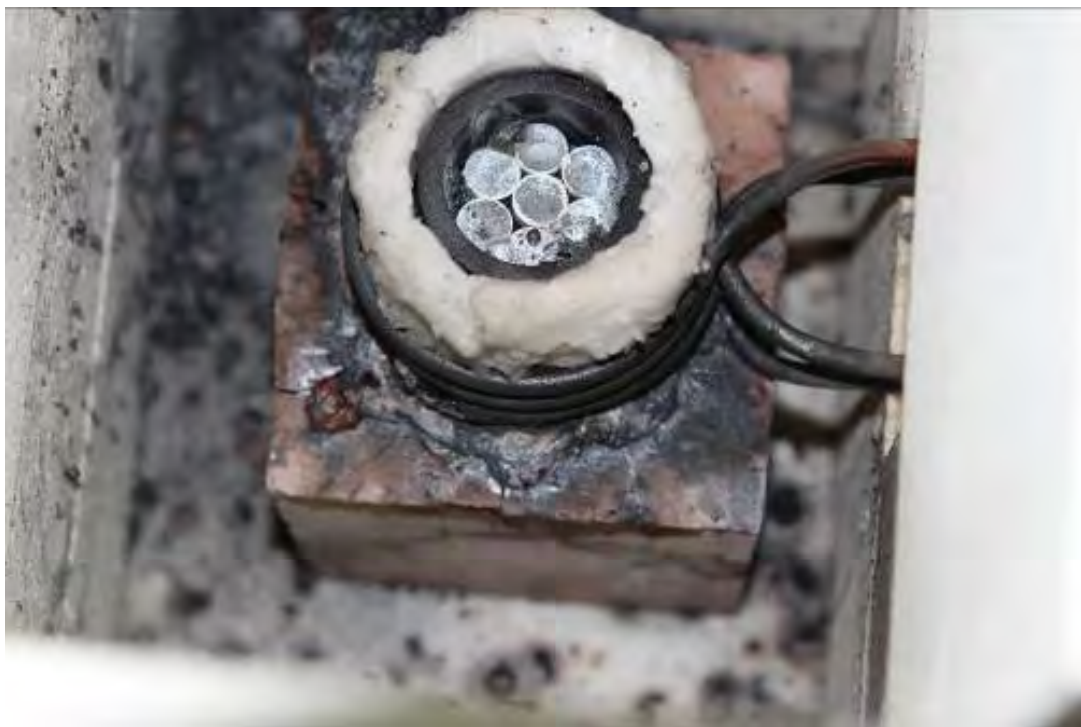
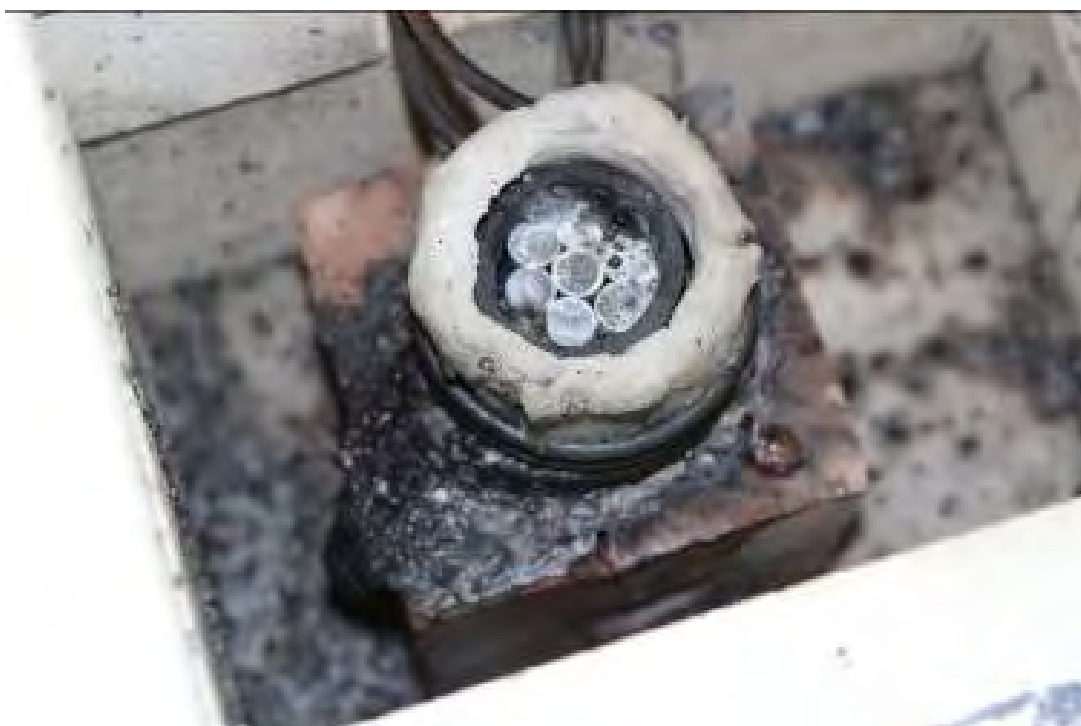
ได้ทำการทดลองครั้งแรกโดยเปิดเครื่อง Induction heater เต็มกำลัง แท่ง Zirconium ร้อนขึ้นเรื่อยๆ จนสว่างจ้าไปทั่วจอมอนิเตอร์ หลังจากนั้นไม่กี่วินาทีก็สังเกตเห็นเปลวไฟติดขึ้นค่อนข้างรุนแรงภายในกรอบอะคริลิค (จากการสังเกตด้วยตาจากระยะไกล) จึงทำการหยุดเครื่องและหลังจากไม่เกิดอะไรขึ้นจึงเดินเครื่องต่ออีกครั้ง แท่ง Zirconium ก็ร้อนขึ้นเรื่อยๆ จนสว่างจ้าไปทั่วจอมอนิเตอร์อีกครั้งและก็เกิดเปลวไฟขึ้นอีก จึงทำการหยุดเครื่องและตรวจสอบดูว่าเกิดอะไรขึ้น รูปที่ 9(a) - 9(c) แสดงความเสียหายที่เกิดขึ้นบริเวณชิ้นงาน

**รูปที่ 9(a) - 9(c) ความเสียหายที่เกิดขึ้นบริเวณชิ้นงาน**

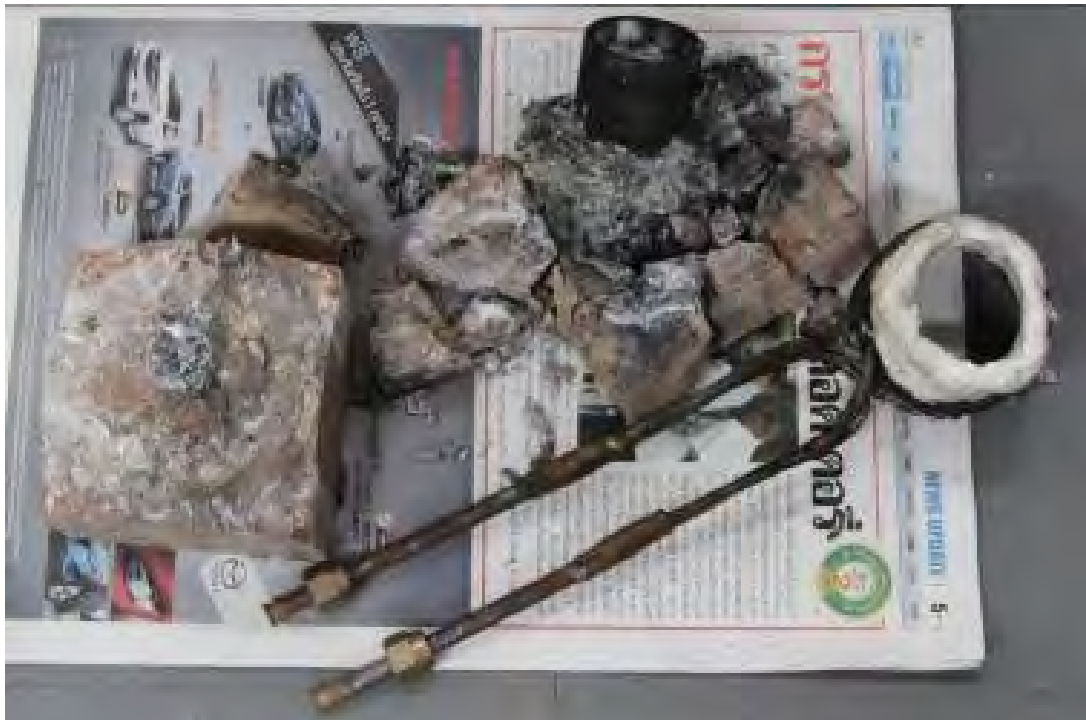
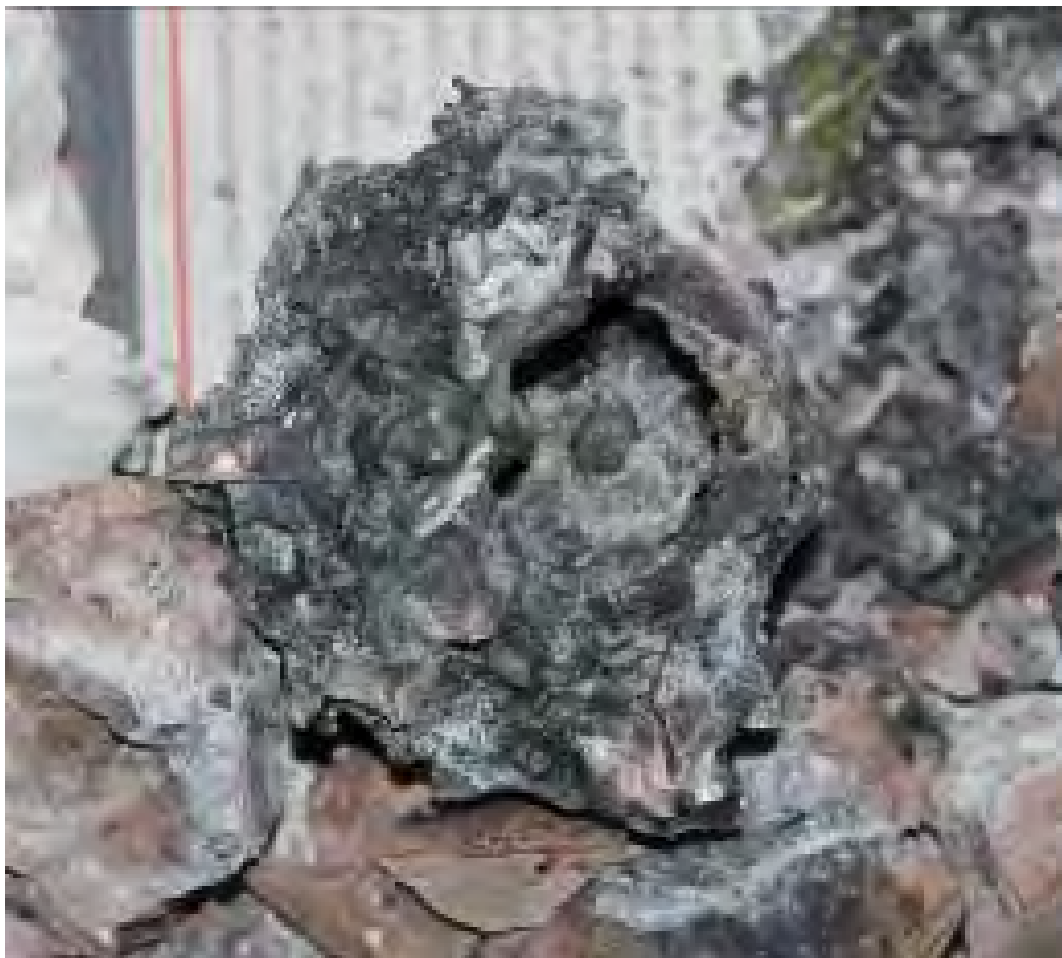
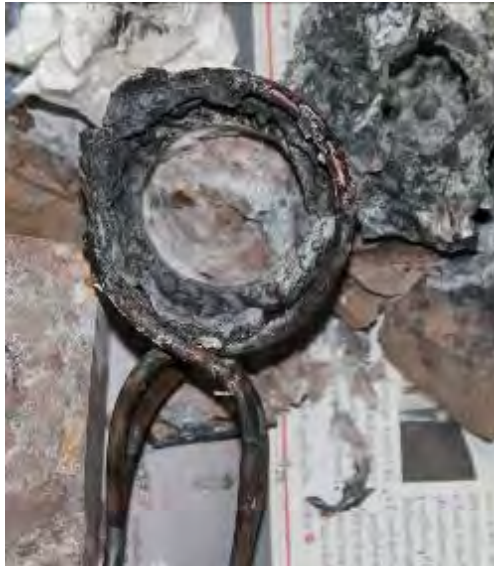
จากการตรวจสอบ พบว่าแท่งเซอร์โคเนียมได้ละลายและออกมาสัมผัสกับ Induction coil ทำให้เกิดน้ำรั่วออกมาด้วย ทั้ง Coil และแท่งคอนกรีตเกิดความเสียหายและใช้งานต่อไปไม่ได้ ดังแสดงในรูปที่ 10(a) - 10(c)

10(b) บริเวณที่ Zirconium หลอมละลายออกมา (มองจากด้านล่าง)

10(c) Coil ที่เกิดความเสียหายละลายไปบางส่วน  
รูปที่ 10(a) - 10(c) ความเสียหายที่เกิดขึ้นบริเวณชิ้นงานและ Coil

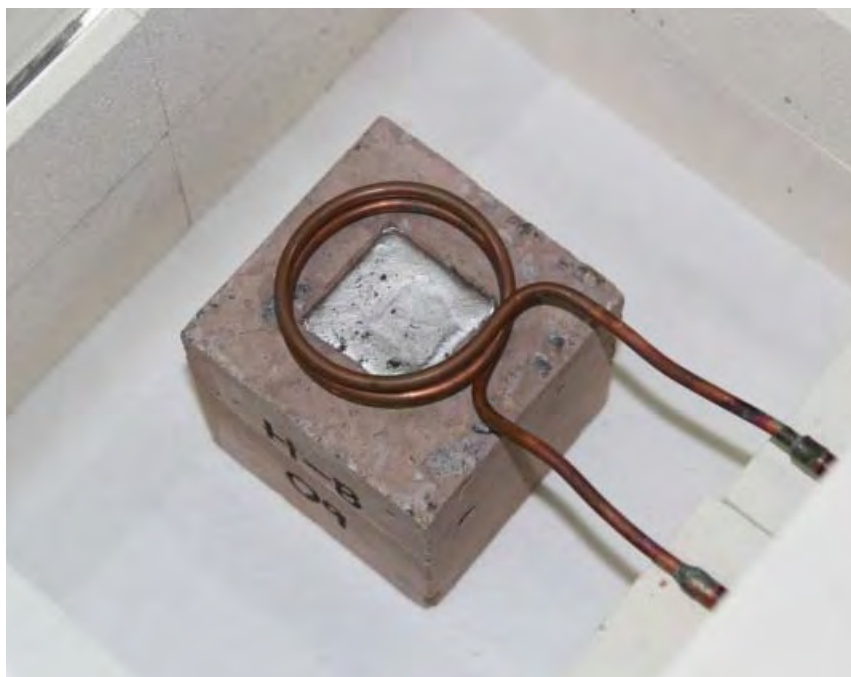
ตามแผนการดำเนินการใหม่ ได้เตรียมโลหะเหลวโดยหลอมตะกั่ว ดีบุกและบิสมัทเข้าด้วยกันที่อัตราส่วนที่เท่ากันโดยน้ำหนักของโลหะแต่ละประเภท และเทใส่ลงในเบ้าของ High density concrete และจัดวางใน Induction heater ดังแสดงในรูปที่ 11

รูปที่ 11 โลหะเหลวใน High density concrete ซึ่งมี Heating coil อยู่ด้านบน  
(ยังไม่ได้ใส่ฉนวนกันความร้อนรอบๆ Coil เพื่อให้สามารถเห็นโลหะเหลวได้อย่างชัดเจน)

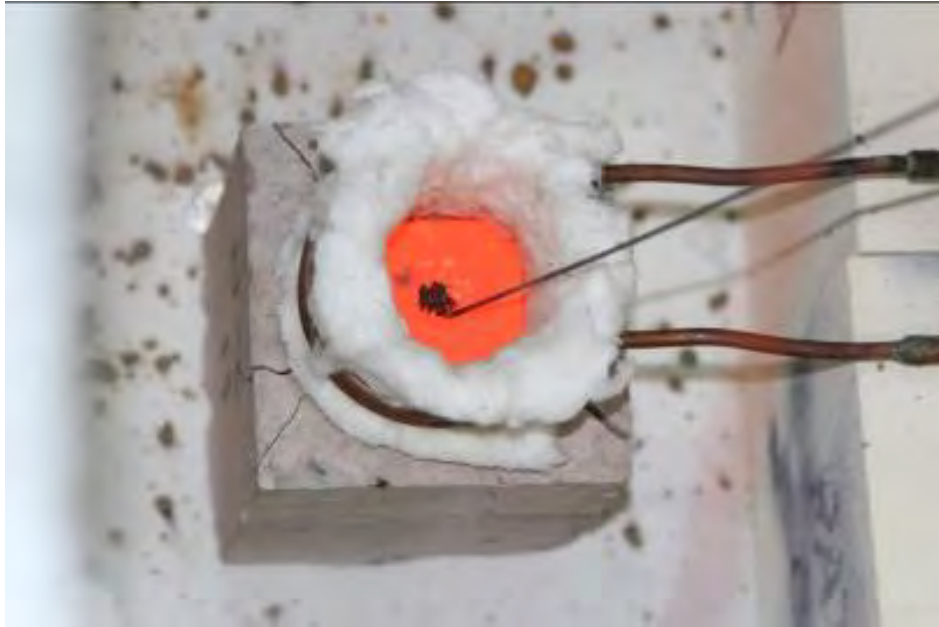
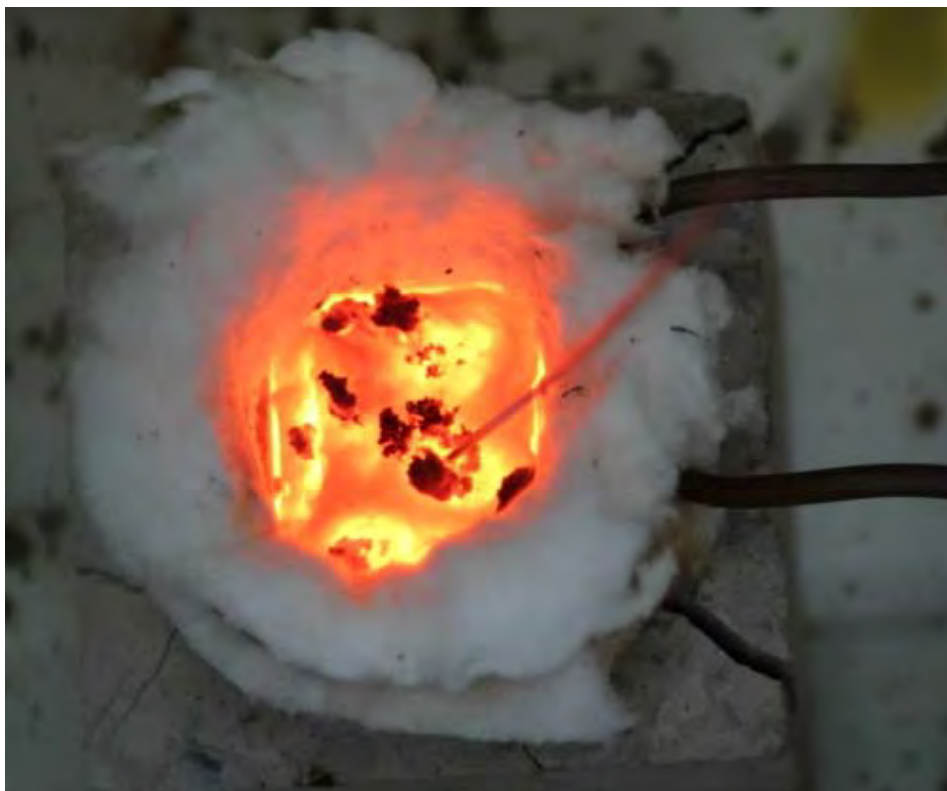
หลังจากนั้นเปิดเครื่องโดยควบคุมระดับกำลังของเครื่องให้โลหะเหลวมีอุณหภูมิอยู่ในช่วง  $1,000 - 1180^{\circ}\text{C}$  เป็นเวลา 14 ชั่วโมง ซึ่งจากคุณสมบัติของโลหะเหลวนี้ที่ไม่ทำปฏิกิริยากับออกซิเจนในอากาศ จึงไม่เกิดไฟไหม้ขึ้นและไม่ได้เกิดการประทุขึ้นแต่อย่างใดด้วย รูปที่ 12(a) - 12(b) แสดงโลหะเหลวที่ร้อนขึ้นระหว่างการทดลอง

รูปที่ 12(a) - 12(b) โลหะเหลวที่ร้อนขึ้นระหว่างการทดลอง

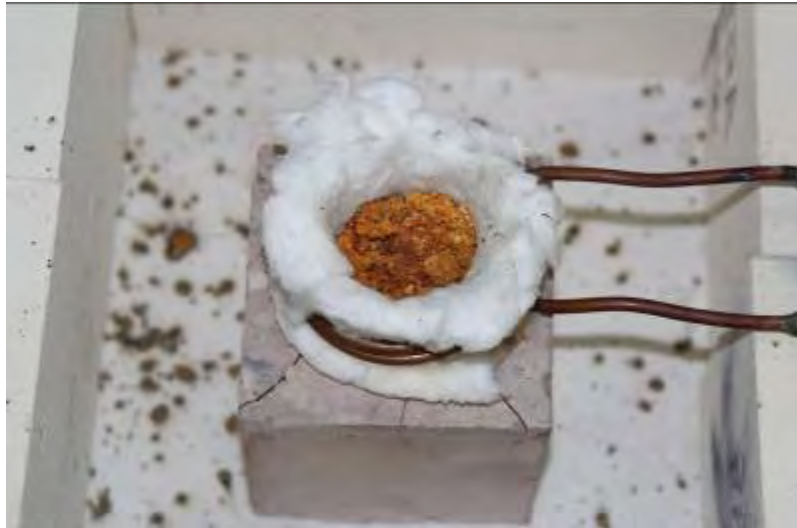
หลังทำการทดลองครบ 14 ชั่วโมงแล้ว ก็จะนำแท่งคอนกรีตออกมา สามารถสังเกตเห็นการฟอร์มตัวของวัสดุแข็งสีเหลืองส้มด้านบนของโลหะเหลวดังแสดงในรูปที่ 13 (สังเกตเห็นตั้งแต่ในช่วง 1-2 ชั่วโมงแรกของการให้ความร้อนแล้ว) จากการวิเคราะห์เบื้องต้นน่าจะเป็น Lead oxide เพราะมีสีเหลือง และก็น่าจะมีสารประกอบอื่นๆ จากปฏิกิริยาระหว่างองค์ประกอบของโลหะเหลวกับองค์ประกอบของ High density concrete ด้วย ซึ่งก็จะดำเนินการวิเคราะห์โดยใช้เทคนิค XRF

**รูปที่ 13** ตัวอย่างการฟอร์มตัวของวัสดุแข็งสีเหลืองส้มด้านบนของโลหะเหลว  
(ในความเป็นจริงแล้วได้ทำการทดลองเบื้องต้นในลักษณะนี้หลายครั้งเพื่อดูความเป็นไปได้ของการทดลองใหม่นี้ ทำให้แต่ละรูปไม่ใช่มาจากการทดลองครั้งเดียวกัน)

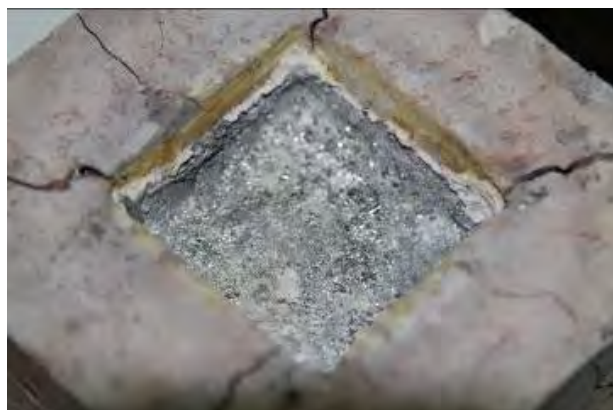
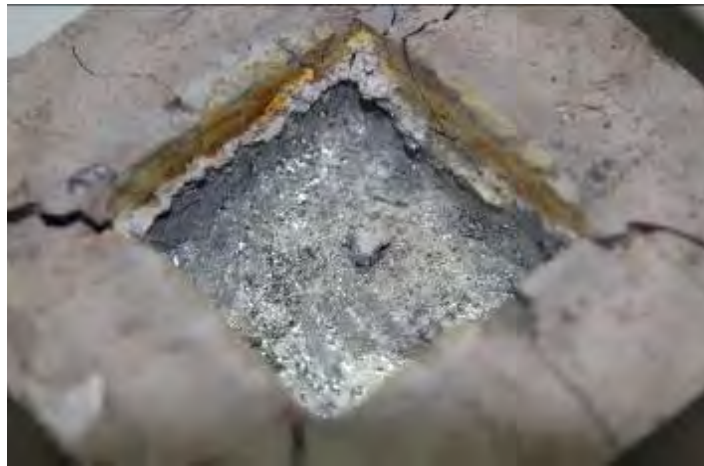
หลังจากนำวัสดุแข็งสีเหลืองส้มออกและเทโลหะเหลวที่ยังละลายอยู่ออกจากเบ้า ก็สามารถสังเกตเห็นภายในของเบ้าได้ดังแสดงในรูปที่ 14(a) - 14(b) ซึ่งสามารถสังเกตเห็นการกัดกร่อนเกิดขึ้นเล็กน้อยและได้ทำการวัดความลึกของเบ้าในหลายๆ ตำแหน่งโดยใช้ไม้มบรรทัด ผลที่ได้คือความลึกเพิ่มขึ้นอย่างมากไม่เกินประมาณ 4 มม. เท่านั้น

รูปที่ 14(a) - 14(b) ภายในของเบ้าใน High density concrete หลังการทดลองแล้วเสร็จ

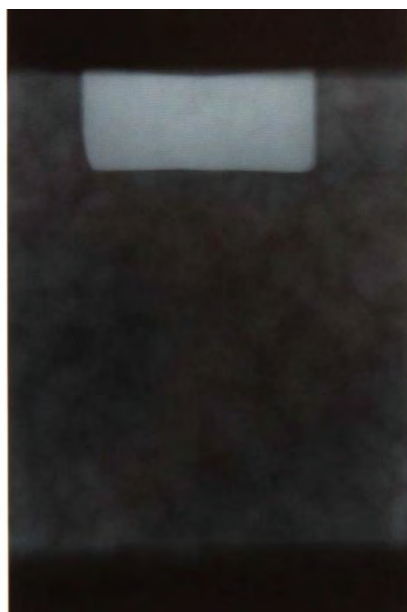
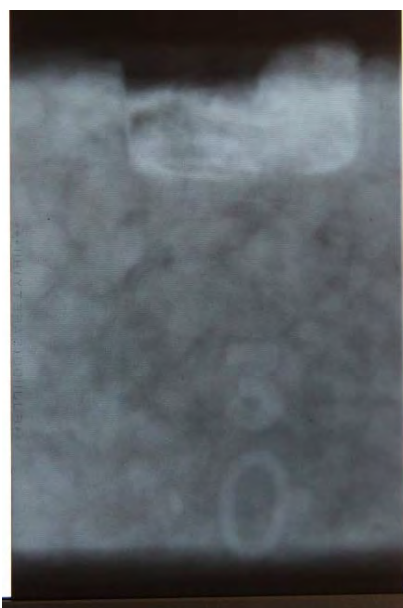
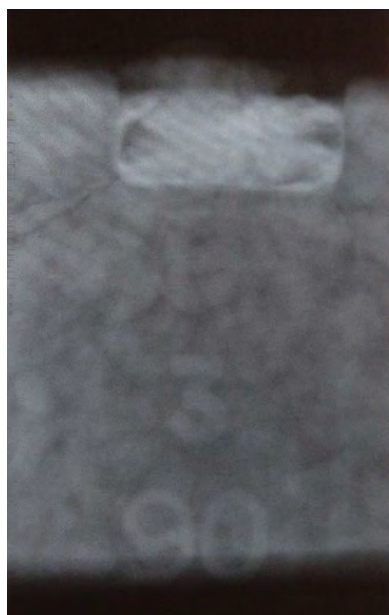
รูปที่ 19(a) – 19(i) แสดงภาพ Gamma radiography เพื่อให้สามารถเห็นการแพร่ของโลหะเหลวลงในคอนกรีตมวลหนัก

**รูปที่ 19 Radiographic images on the XZ and YZ planes before and after the heating experiment at 1,000, 1,200, 1,400 and 1,600°C**

จากภาพ Gamma radiography จะเห็นได้ว่าที่ 1,000°C ถึงแม้ว่าจะคงอุณหภูมิไว้เป็นเวลานานถึง 12 ชั่วโมง แต่ก็ไม่เกิดการแพร่ของโลหะเหลวลงไปในคอนกรีตแต่อย่างใด ส่วนที่ 1,200°C เป็นเวลา 5 ชั่วโมง โลหะเหลวแพร่ลงไปเป็นระยะทางประมาณ 1.3 ซม. แต่ก็หยุดส่วนที่ 1,400°C โลหะเหลวแพร่ลงไปเป็นระยะทางประมาณ 2 ซม. ในช่วงเวลาประมาณ 3 ชั่วโมง ซึ่งสามารถคำนวณเป็นค่าการกักตรอนได้ที่ประมาณ 0.7 ซม. ต่อชั่วโมง ส่วนที่ 1,600°C โลหะเหลวแพร่ลงไปเป็นระยะทางประมาณ 2.9 ซม. ในช่วงเวลาประมาณ 10 นาทีเท่านั้น ซึ่งสามารถคำนวณเป็นค่าการกักตรอนได้ที่ประมาณ 17 ซม. ต่อชั่วโมง

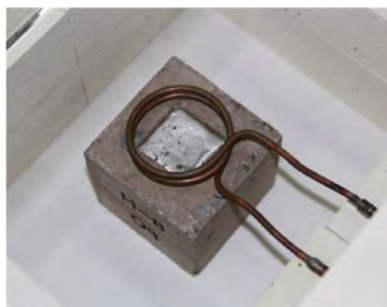
The copper induction coil with water circulation inside was placed on top of the reservoir in the high-density concrete block containing the LM. The coil was connected to a 35 kW Yueqing Kexin induction heater model KX-5188A35. A thermocouple was immersed into the LM with the tip in contact with the concrete in order to measure the actual temperature at the LM-high density concrete interface. For temperature up to 1200 °C, a K-type

**(a)** Drawing of the experimental setup

**(b)** Actual experimental setup (White insulating material on the copper coil was removed for clarity of the heating coil and the LM in the concrete pit)**Fig. 3.** Experimental setup for testing LM-high density concrete corrosion between 1000 and 1600 °C.

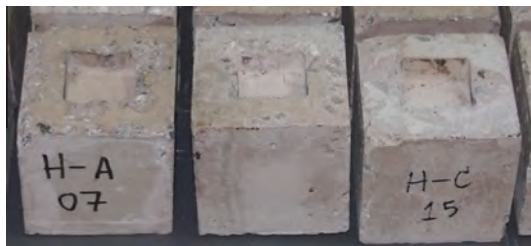
Fig. 7. Examples of fabricated high-density concrete blocks.

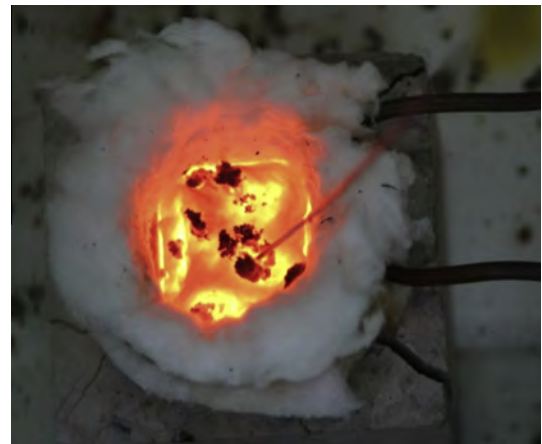
Fig. 8 displays the red-glowing liquid metal in the concrete block due to eddy current generation from coupling with the induction coil above. Small and large cracks in the concrete block due to thermal stress can be seen in the figure. Fig. 9 illustrates the temperature histories.

Fig. 8. Red-glowing liquid metal in the concrete block.
