## บทที่ 5

### การเสริมกำลังจุดต่อคาน-เสาให้สามารถต้านทานแรงเนื่องจากแผ่นดินไหว

#### 5.1 การเสริมกำลังข้อต่อโดยวิธีขยายจุดต่อในระนาบ (Planar joint expansion)

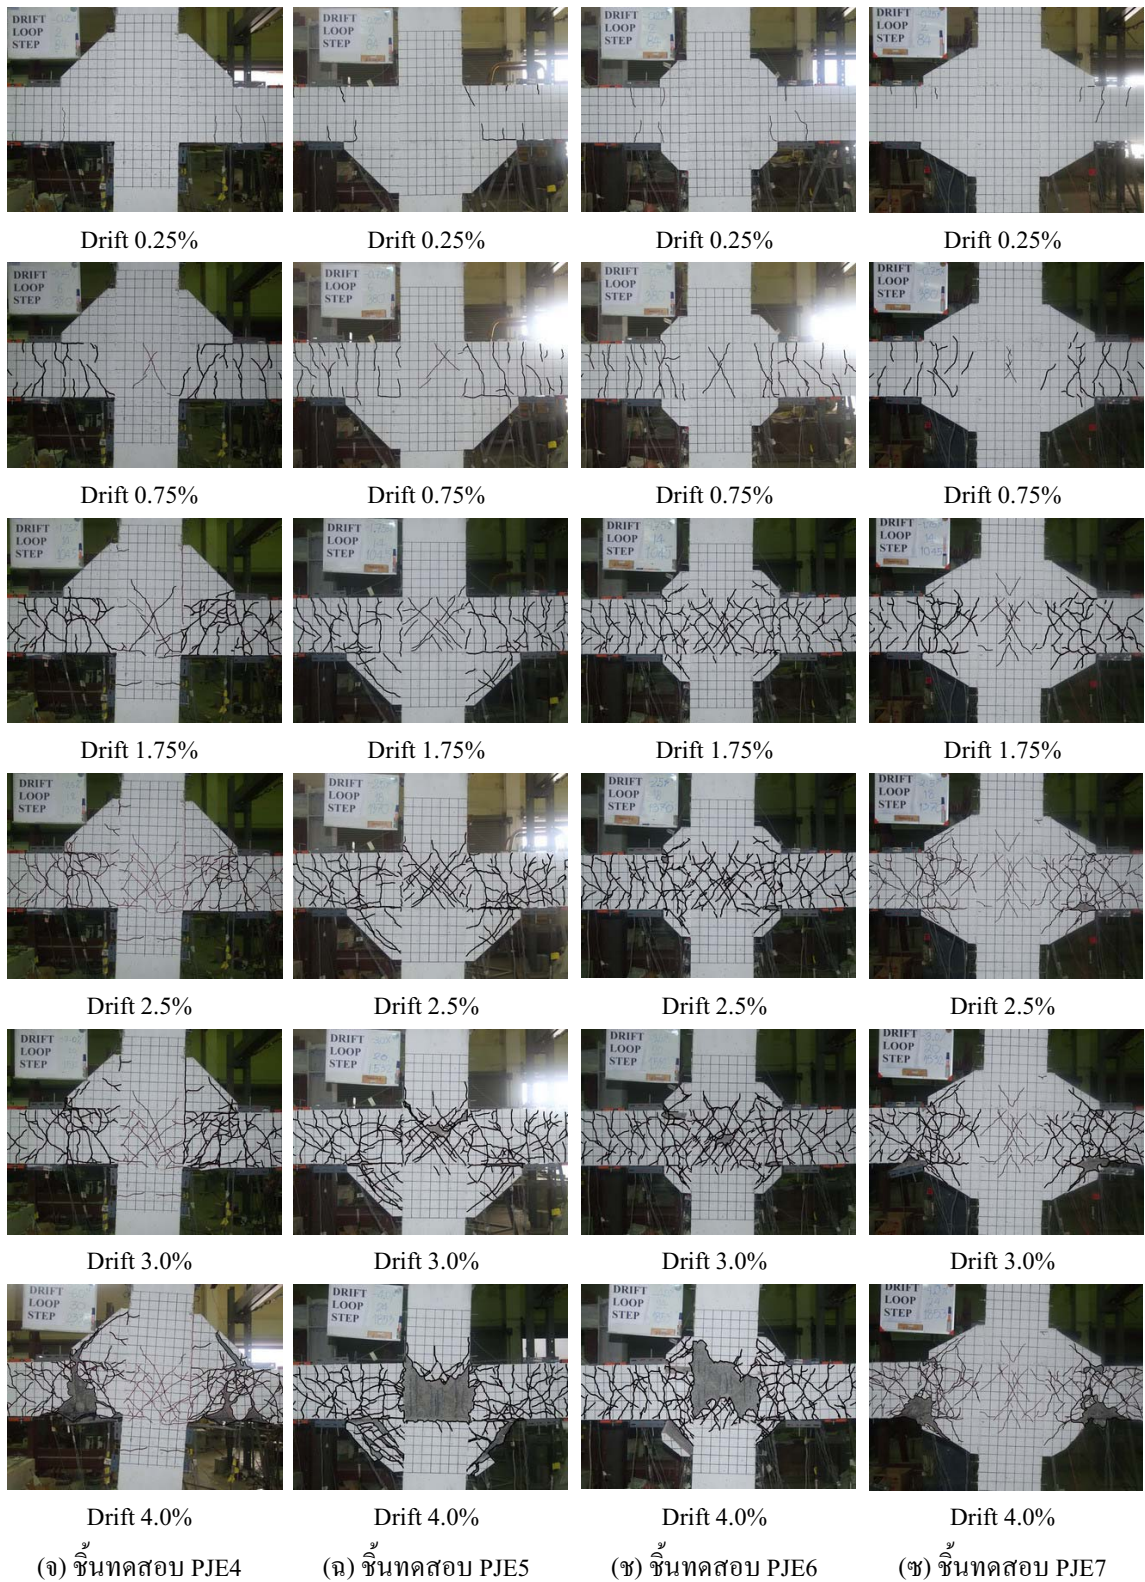
รูปที่ 5.32 พฤติกรรมการเกิดรอยร้าว

รูปที่ 5.32 พฤติกรรมการเกิดรอยร้าว (ต่อ)

ชินทดสอบนี้มีลักษณะคล้ายชินทดสอบ PJE2 แต่ส่วนขยายมีความสูงเพียง 200 มม. ตามแนวเสา พบรอยร้าวตัดในคานเช่นเดียวกับชินทดสอบอื่น ๆ ที่ระยะเคลื่อนที่  $\pm 0.25\%$  หลังจากนั้นเริ่มปรากฏรอยร้าวเฉือนในจุดต่อ (รูปที่ 5.32ข) ที่ระยะเคลื่อนที่สัมพัทธ์  $\pm 0.75\%$  ที่ระยะเคลื่อนที่  $\pm 1.50\%$  พบรอยร้าวกระจายทั่วจุดต่อ คานและส่วนเสริมกำลัง ที่ระยะเคลื่อนที่  $\pm 2.5\%$  รอยร้าวในคานปรากฏเด่นชัดขึ้น พร้อมทั้งเกิดความเสียหายที่มากขึ้นในส่วนเสริมกำลังเช่นกัน ที่ระยะเคลื่อนที่สัมพัทธ์  $\pm 3.0\%$  คอนกรีตหุ้มด้านข้างคานเริ่มหลุดกะเทาะออก ที่ระยะเคลื่อนที่  $\pm 4.0\%$  คอนกรีตหุ้มในคานกะเทาะออกจนสามารถมองเห็นเหล็กนอนในคานโค้งตัว คอนกรีตส่วนเสริมกำลังหลุดออกเป็นชิ้น ๆ รูปแบบการวิบัติเกิดความเสียหายของจุดหมุนพลาสติกในคานที่บริเวณปลายของส่วนเสริมกำลัง

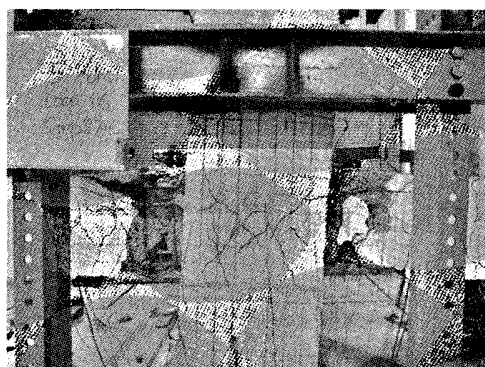
Fig. 8. Failure of specimen: (a) failure of specimen JL; (b) failure of specimen JM; (c) failure of specimen JS

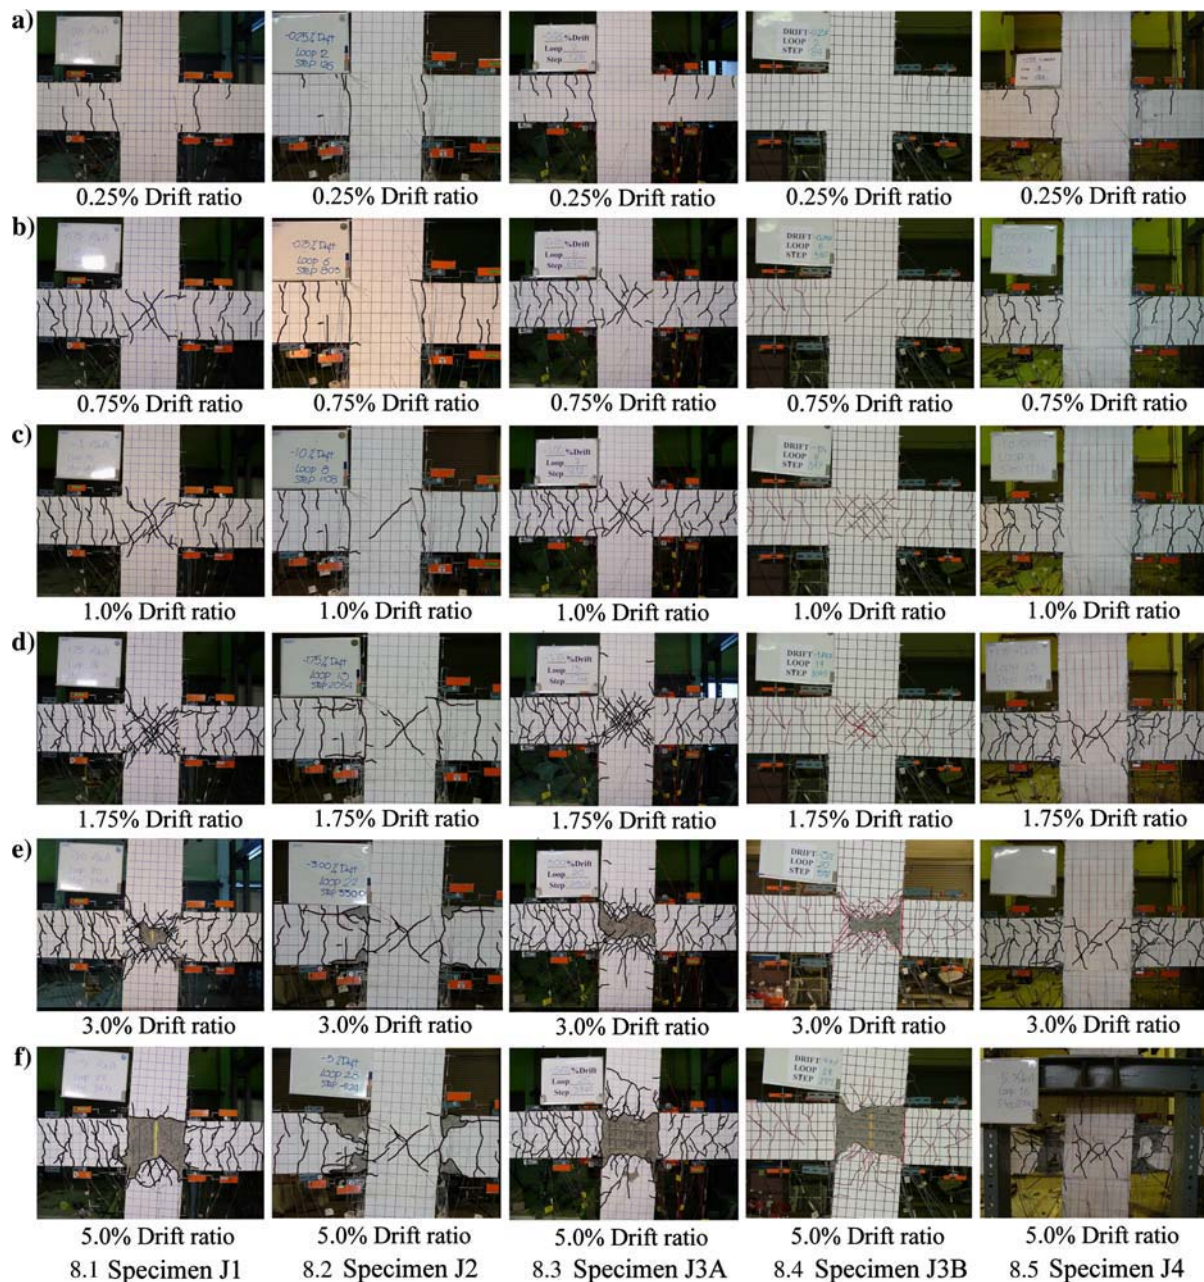
**Fig. 8** Progress of cracking development of each specimen
