**Keywords** Substandard beam-column connection · Joint shear failure · Seismic retrofit · Planar joint expansion · Plastic hinge

**Fig. 1** 3D Beam-column frame system retrofitted with planar joint expansion

**ABSTRACT:** This paper presents a nonlinear finite element analysis of non-seismically detailed reinforced concrete (RC) beam-column connections under reversed cyclic load. The test of half-scale nonductile reinforced concrete beam-column joints was conducted. The tested specimens represented those of the actual mid-rise reinforced concrete frame buildings designed according to the non-seismic provisions of the American Concrete building code (ACI). The test results show that the specimens representing small and medium column tributary area failed in brittle joint shear while the specimen representing large column tributary area failed by ductile flexure though no ductile reinforcement details were provided. The nonlinear finite element analysis was applied to simulate the behavior of the specimens. The finite element analysis employed the smeared crack approach for modeling beam, column and joint, and employed the discrete crack approach for modeling the interface between

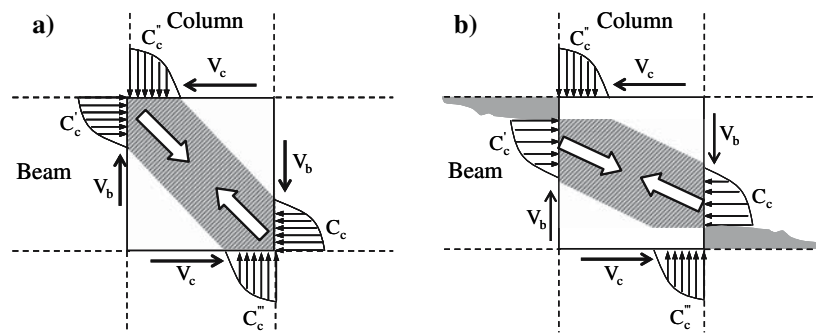
**Fig. 15** Change in strut geometry after spalling of beam section. (a) Concrete diagonal strut. (b) Concrete strut after spalling of beam section

5. In specimen with un-bonded bar, the loss of spalled concrete section may reduce the joint shear force by moving down the compression stress block. The compression resultant on

opposite faces then became aligned with flatter inclination. The capacity of compression strut thus increases, which prevents joint shear failure and reduces joint damage.

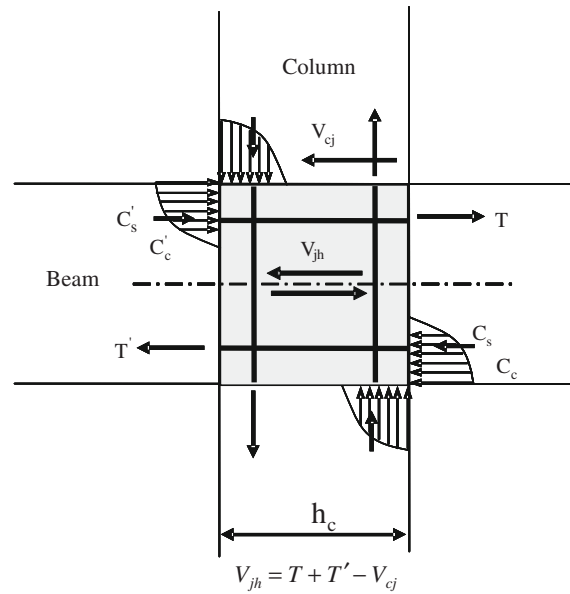
**Fig. 2** Definition of joint shear  $V_{jh}$

According to the New Zealand code [17], the joint shear stress must not be greater than  $0.2f'_c$  to avoid joint shear failure. Regarding anchorage bond failure, the ACI code [18] requires the minimum column depth to bar diameter ratio ( $h_c/d_b$ ) of 20. The New Zealand standard [17] provides different equations to calculate required  $h_c/d_b$  depending on whether the frame is ductile or limitedly ductile. The requirement

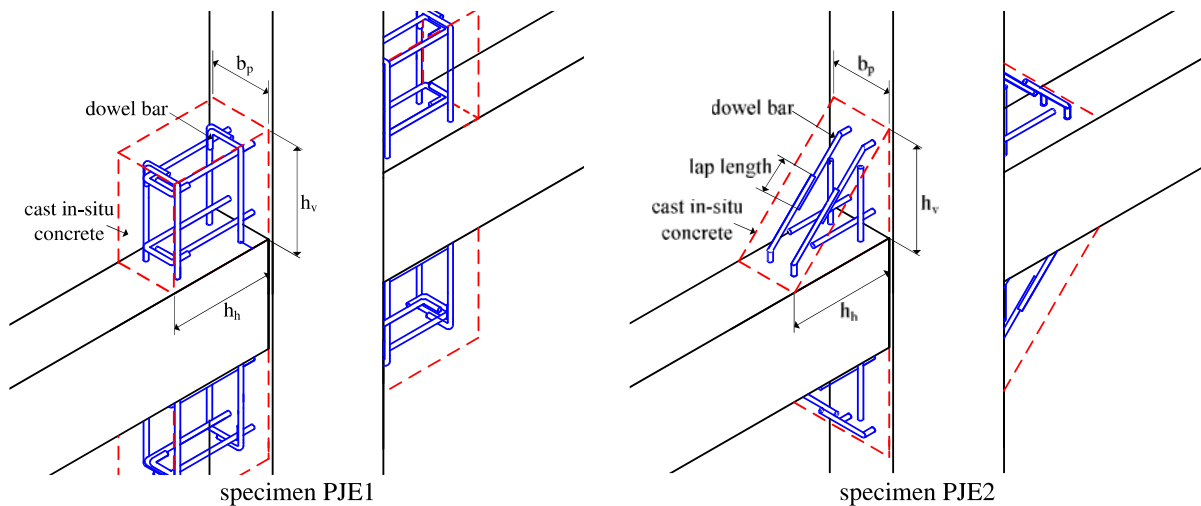
Fig. 3 3D view of planar expansion: geometry and reinforcement

The dimension of joint planar expansion is  $h_h \times h_v \times b_p$  as shown in Fig. 3. The width  $b_p$  is set equal to the beam width. Dowel bars are used to fix cast in-situ expansion to beam and column. The authors propose the following design recommendations to obtain the size and reinforcement detail of planar joint expansion,

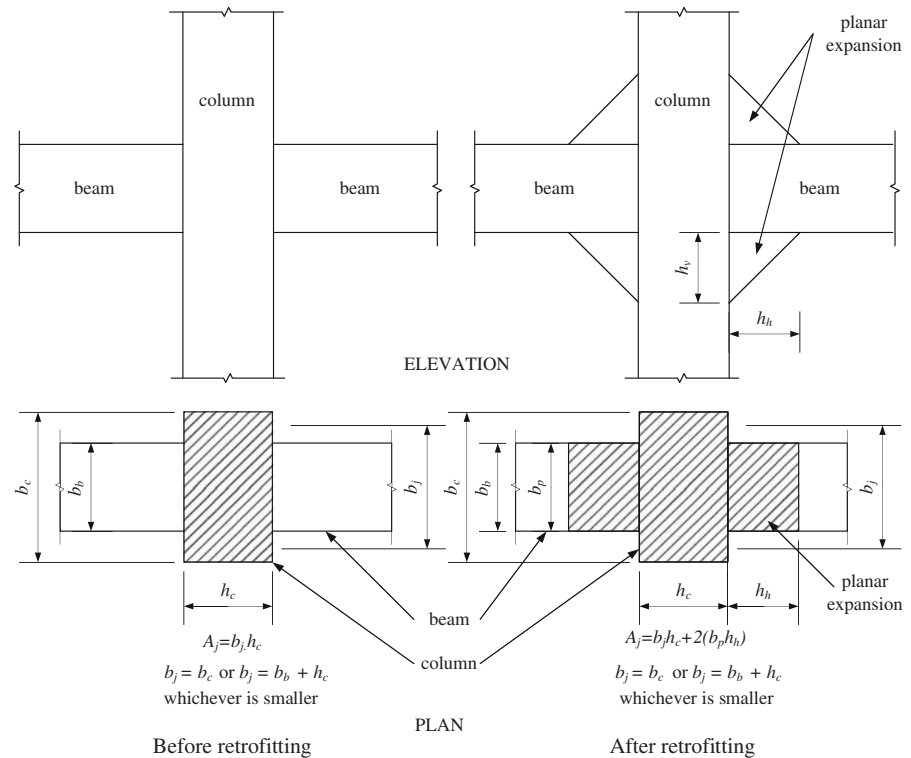
**Fig. 4** Effective joint area

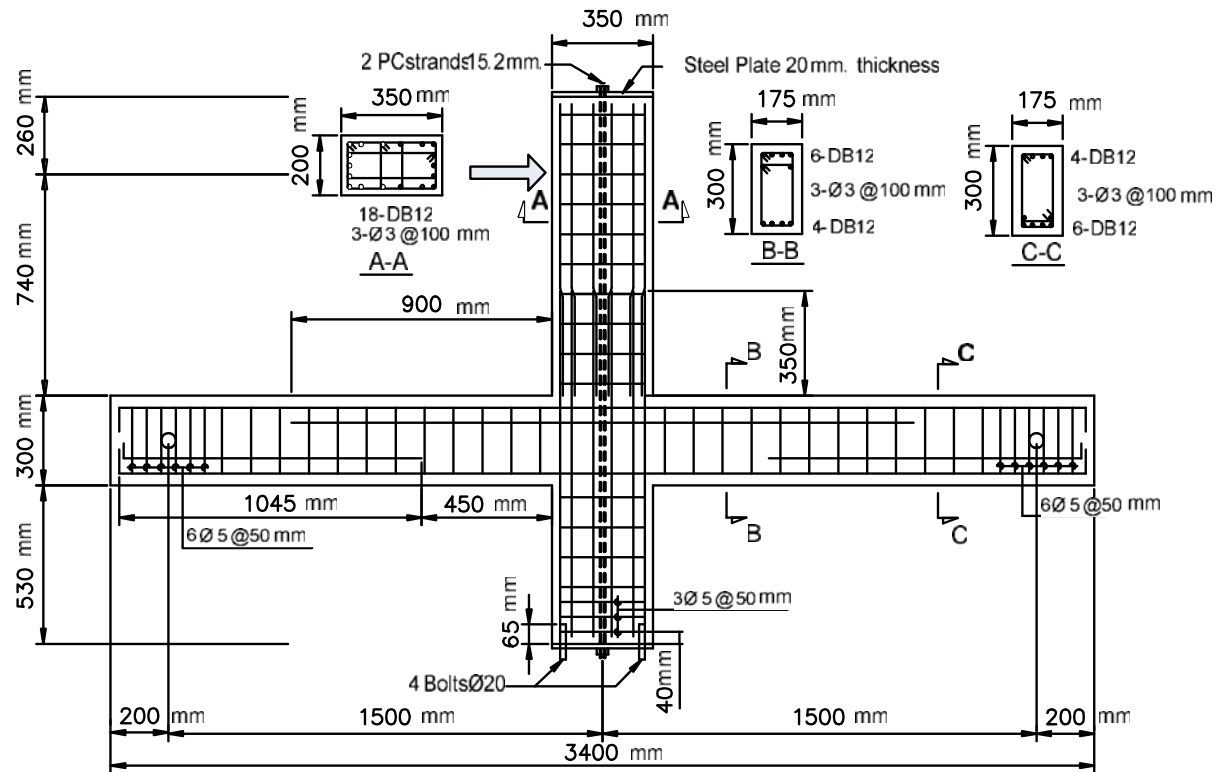
**Fig. 5** Dimension and reinforcing detail of the control specimen

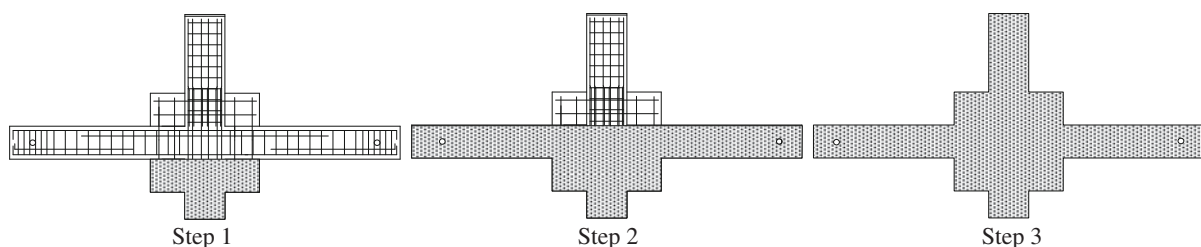
Fig. 7 Construction stages of specimen PJE1

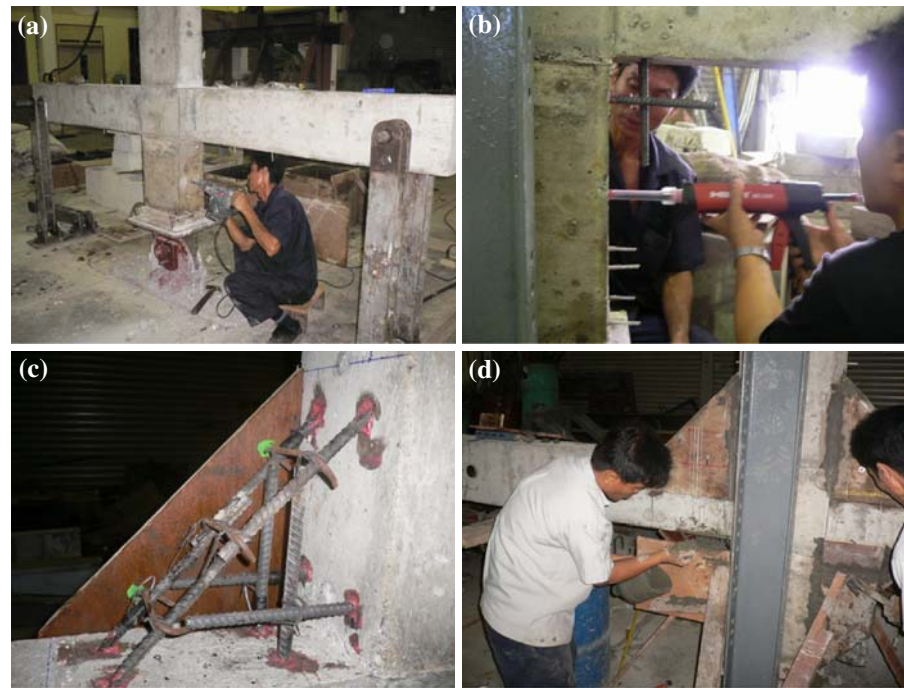
**Fig. 8** Construction stages of specimen PJE2. (a) Drilling column and beam. (b) Inserting dowel bars and injecting epoxy into drilled hole. (c) Reinforcement after epoxy injection. (d) Casting concrete

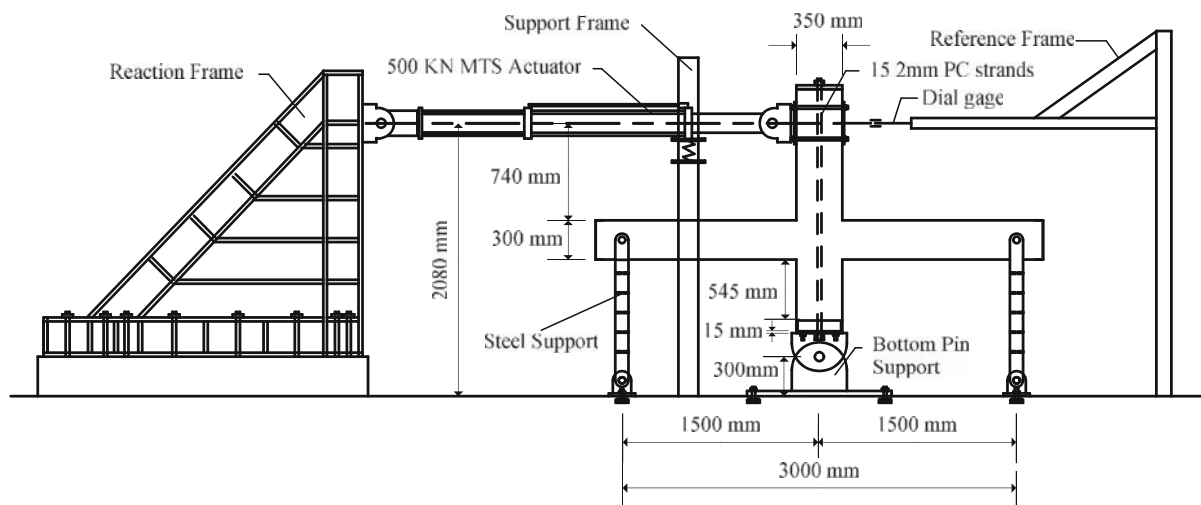
**Fig. 9** Test set-up

The test set-up and boundary conditions are shown in Fig. 9. The lateral displacement was applied at the top of the column through a 500 kN hydraulic actuator. The ends of beam were supported by rollers that allowed free horizontal movement to simulate lateral drift. The bottom end of the column was supported by a hinge which allowed no movement in all directions. To simulate gravity load on column, the axial load of 12.5% column axial capacity was applied to the column by means of vertical prestressing. The column was pushed forward and pulled

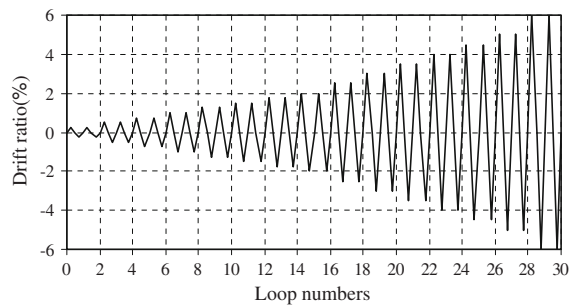
**Fig. 10** Displacement history

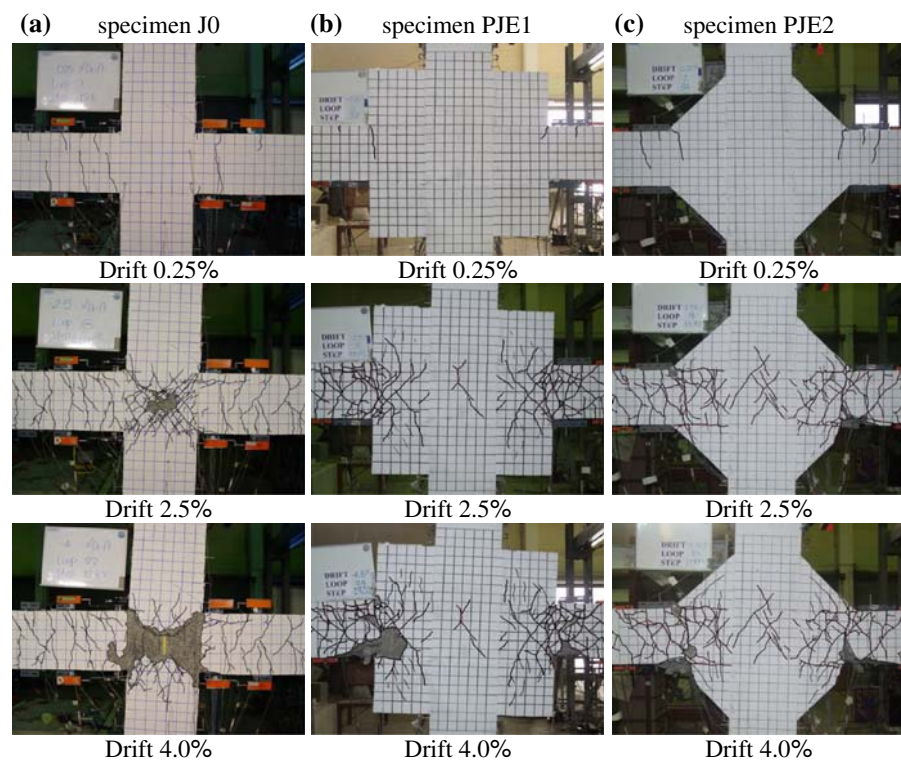
**Fig. 11** Crack observation.

- (a) Specimen J0.
- (b) Specimen PJE1.
- (c) Specimen PJE2

The cracking behavior of the control specimen is illustrated in Fig. 11a. At  $\pm 0.25\%$  drift ratio, the first

flexural crack occurred in beam. At  $\pm 0.5\%$  drift ratio, the first diagonal crack occurred at joint. As drift ratio increased, these flexural and diagonal cracks grew in size and number. At  $\pm 0.75\%$  drift ratio, splitting crack occurred along longitudinal beam bar in joint. Since  $\pm 1.0\%$  drift ratio, the cracks were mainly concentrated in the joint region. These cracks formed typical X-shaped pattern as shown in Fig. 11a. The specimen reached the peak load of 72 kN at 1.75% drift ratio. At  $\pm 2.0\%$  drift ratio, the concrete in the joint spalled off, exposing column longitudinal bars. The load was continued with substantial damage in joint until  $\pm 5.0\%$  drift ratio.

The cracking behavior of specimen PJE1 is illustrated in Fig. 11b. At  $\pm 0.25\%$  drift ratio, flexural crack occurred at the edge of joint expansion in beam. At

$\pm 0.50\%$  drift ratio, several flexural cracks formed in both sides of beam. At  $\pm 1.0\%$  drift ratio, diagonal cracks in beams extended and passed through the joint expansion. At  $\pm 1.50\%$  drift ratio, diagonal crack occurred in joint. Visible flexural cracks were found in beam at the edge of joint expansion on both sides at  $\pm 2.0\%$  drift ratio. At  $\pm 3.0\%$  drift ratio, concrete cover spalled off at the bottom face of beam, exposing buckled longitudinal beam bars. One leg of stirrup on both sides of the beam was broken at  $\pm 3.5\%$  drift ratio. The load was continued with significant damage in beam until  $\pm 4.0\%$  drift ratio.

The cracking behavior of specimen PJE2 is illustrated in Fig. 11c. At  $\pm 0.25\%$  drift ratio, the first flexural crack occurred at the edge of joint expansion in beam. The specimen has about 18% higher initial elastic stiffness as compared with the control specimen. At  $\pm 0.75\%$  drift ratio, the horizontal crack occurred along the construction joint. Since  $\pm 1.25\%$  drift ratio, the first diagonal crack occurred in joint and stopped at  $\pm 1.75\%$  drift ratio. At  $\pm 2.5\%$  drift ratio, concrete cover at the bottom face of beam spalled off, exposing buckled bottom beam bars.

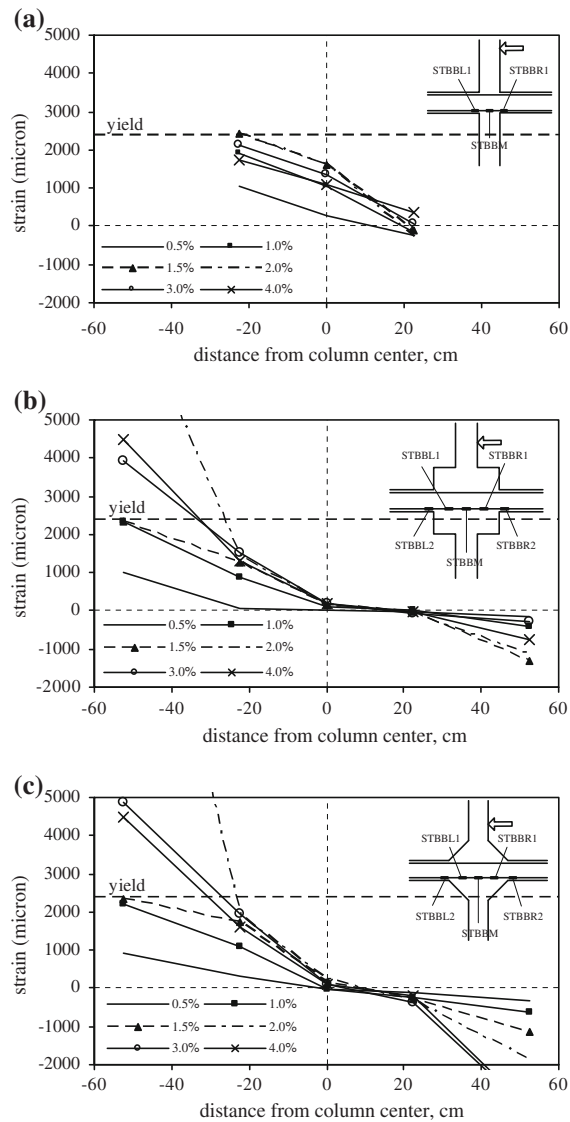
**Fig. 13** Strain along bottom beam bar. (a) Control specimen J0. (b) Specimen PJE1. (c) Specimen PJE2

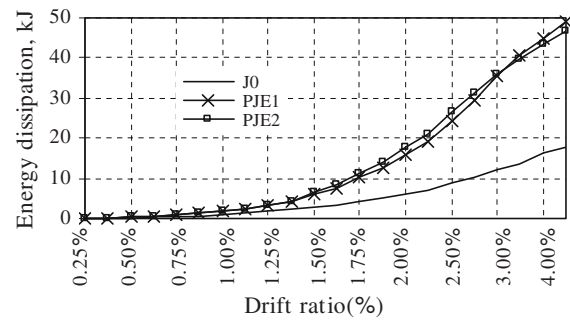
**Fig. 14** Cumulative energy dissipation

The energy dissipated by the specimen was computed as the area within hysteresis loops of the column shear force-displacement relation. The total cumulative energy dissipation (Fig. 14) was calculated as the sum of cumulative energy in the two loading directions. The comparison of energy dissipation among three specimens is illustrated in Fig. 14. The energy dissipated from the beginning till  $\pm 4.0\%$  drift ratio of control specimen J0, specimen PJE1 and PJE2 is 17.9, 49.0 and 46.6 kJ, respectively. As shown, retrofitted specimens dissipated more energy than the control specimen up to 173 and 160% for specimen PJE1 and PJE2, respectively.

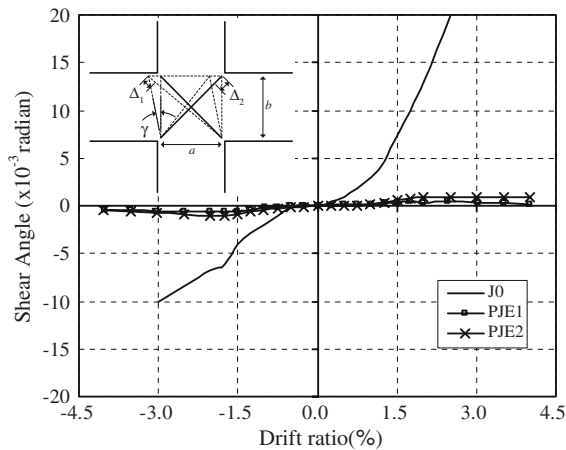
**Fig. 15** Relationship between joint shear angle and drift ratio

The joint shear deformation ( $\gamma$ ) represents the damage condition of joint. The shear deformation was measured by two displacement transducers ( $\Delta_1$  and  $\Delta_2$ ) installed diagonally with respect to the beam's axis. The average joint shear deformation was calculated from

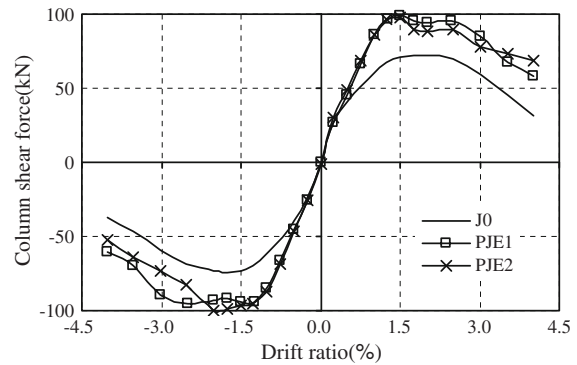
**Fig. 17** Relationship between envelope of column shear force and drift ratio

From Figs. 17 and 18, it is seen that while the column shear envelope of control specimen is lower than that of

retrofitted specimens, the horizontal joint shear is greater. The lower horizontal shear transmitted to the joint of retrofitted specimens is due to lower tensile strains in steel bars at column faces. Thus the joint expansion reduces the joint shear stress transmitted to the joint and protects the joint from shear failure.

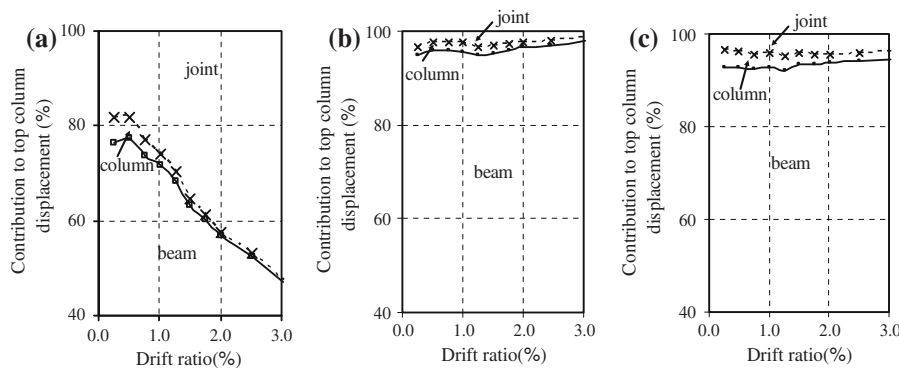
**Fig. 16** Contribution of beam, column and joint deformation to horizontal top column displacement. (a) Control specimen J0. (b) Specimen PJE1. (c) PJE2 specimen PJE2

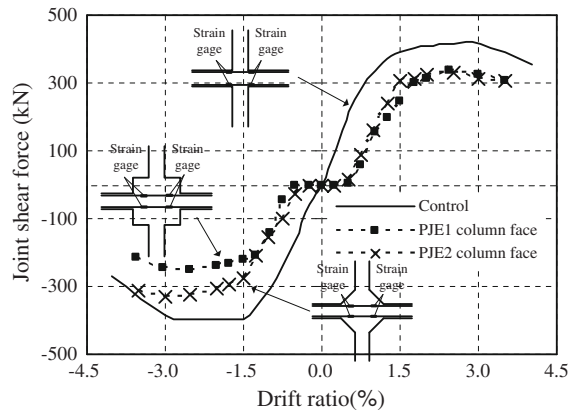
**Fig. 18** Relationship between joint shear force and drift ratio measured at column face

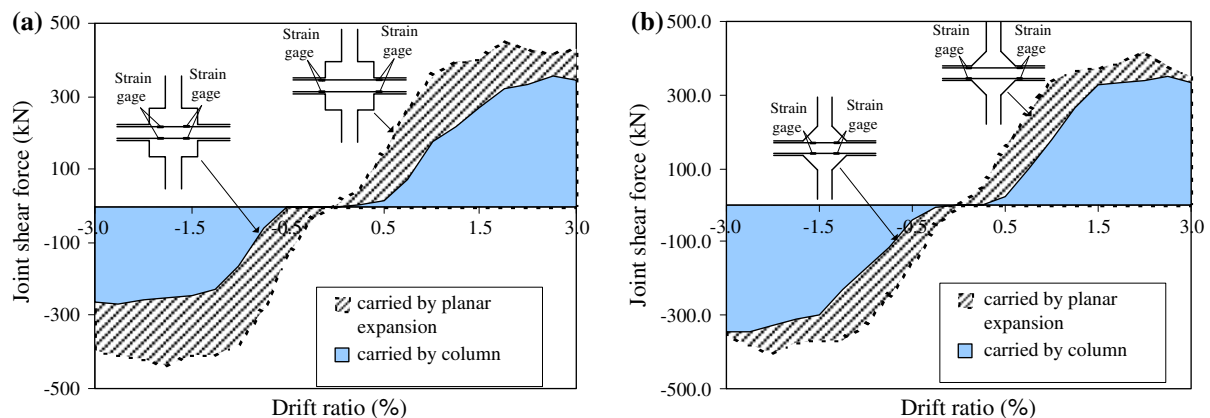
**Fig. 19** Resistance of horizontal shear force by joint core and by expansion. (a) Specimen PJE1. (b) Specimen PJE2

Figure 19 shows the plot of horizontal shear force obtained from measured strains at column faces (solid line) and at the edge of joint expansion (dotted line) for retrofitted specimens. The horizontal shear force obtained from measured strains at column faces represents shear force transferred by joint core, while that obtained from measured strains at the edge of joint expansion represents the total shear force transferred by joint core and expansion. The difference between the two graphs represents the part of horizontal shear transferred by planar expansion. Since the contribution of horizontal shear by joint

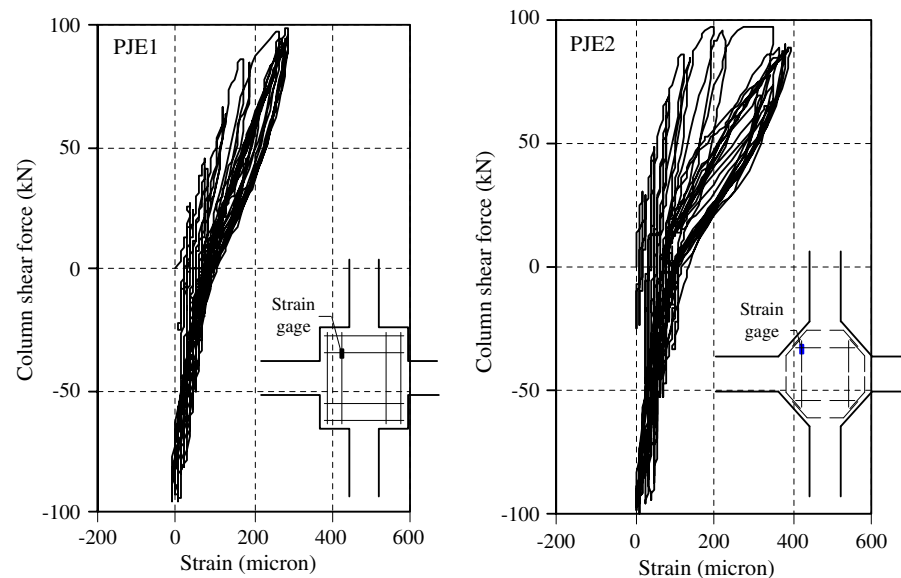
**Fig. 20** Relationship between column shear force and measured strains in dowels

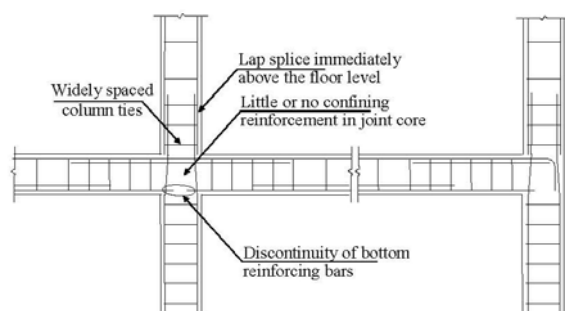
Fig 1. Typical non-seismic reinforcing detail of RC frame designed for gravity load only.

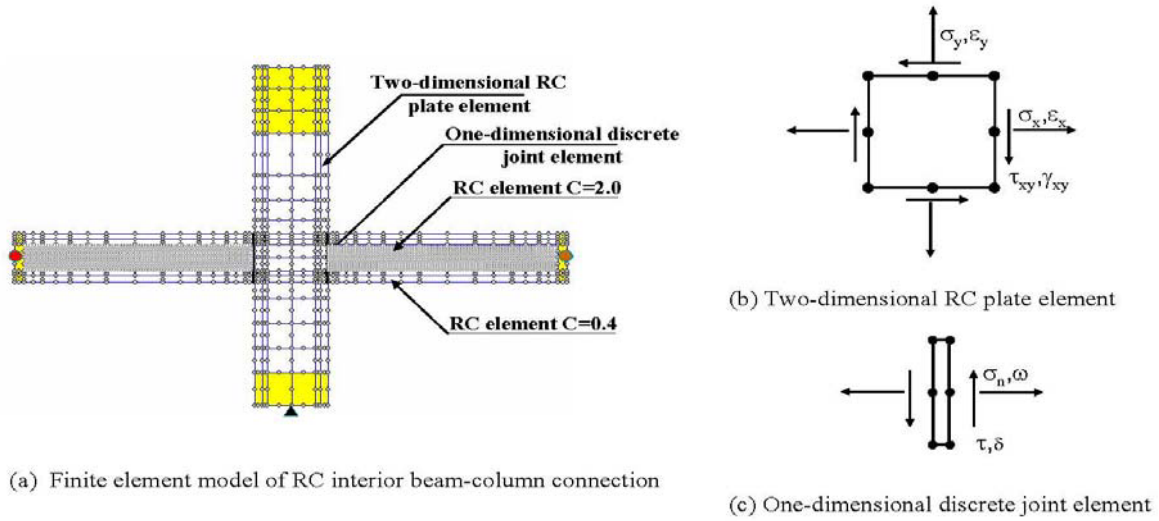
**Fig 3.** Finite element model of RC interior beam-column connection and Types of RC element.

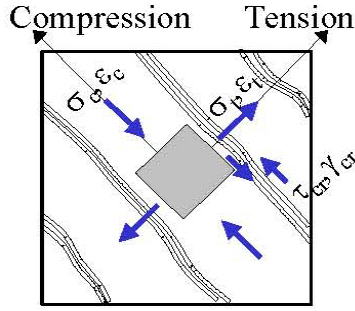
Fig 4. Local stresses and strains of cracked concrete.

The local strains of cracked concrete are defined with respect to the crack axis. They consist of strain normal to a crack, strain parallel to a crack and the shear strain along a crack face as shown in Fig. 4. Input variables for constitutive laws are local strains defined above as well as relevant path-dependent parameters. The constitutive laws are formulated for both envelope and hysteretic loops. Under cyclic load, two sets of diagonal cracks are generated and alternate between opening and closing in accordance with the load direction. At any load step, however, only a set of cracks is active and principally contributes to the nonlinearity of the element. The active crack is defined

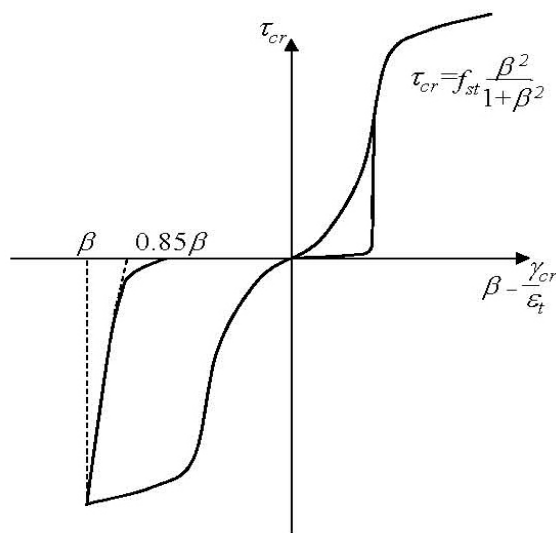
Fig 6. Shear stress transfer model.

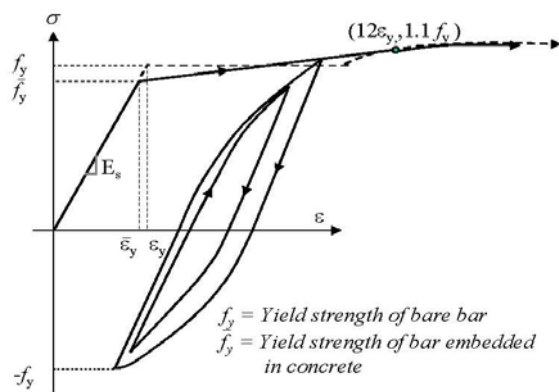
Fig 7. Modeling of reinforcing bar.

The model of reinforcing bar for both envelope and hysteretic loops<sup>6</sup> is shown in Fig. 7. The figure also shows that of bare bar for comparison.

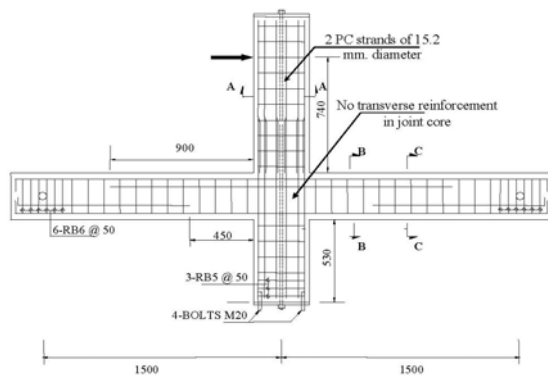
**Fig 8.** Geometry, dimension and reinforcement of all specimens (unit: mm).

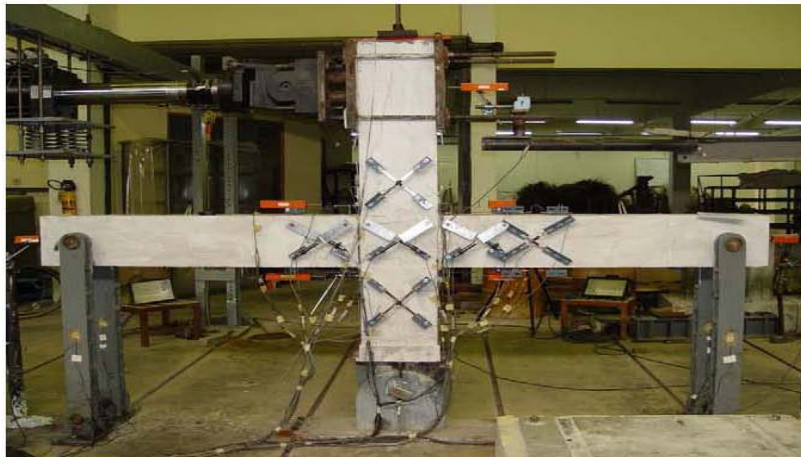
(a) Laboratory test set-up

The test set-up and boundary conditions are shown in Fig. 10(a). The lateral forced displacement was applied at the top of the column through a 500 kN hydraulic actuator. The ends of the beam were supported by rollers that allowed free horizontal movement to simulate lateral drift. The bottom end of the column was supported by a hinge which allowed no movement in all directions. The axial load of 12.5% of column axial capacity was applied to the column by means of vertical prestressing. The column was pushed forward and pulled backward in a reversed cyclic pattern with the target lateral drifts of 0.25%, 0.50%, 0.75%... as shown in Figs. 10(b) and 10(c). The target loop was repeated twice for each drift level. The load was continued until and beyond the peak load to trace the post-peak behavior. The experimental results shall be presented and discussed in conjunction with the numerical analysis in the next section.

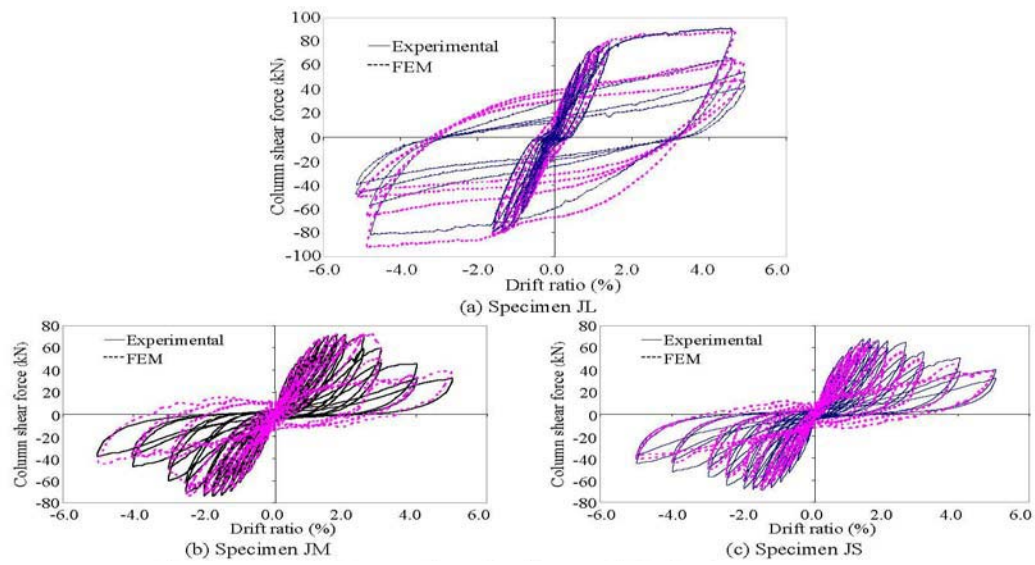
Fig 12. Relationship between column shear force and drift ratio of each specimen.

The comparison between experimental and numerical load versus applied displacement relation is shown in Figs. 12(b) and 12(c) for specimen JM and JS,

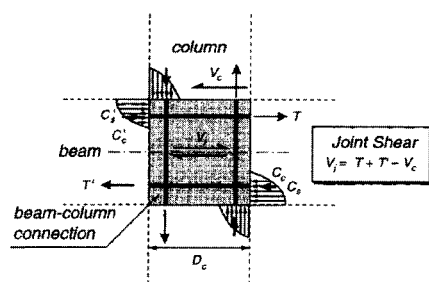
Figure 1 Joint shear force

determines the joint shear failure. Moreover, the longitudinal beam reinforcing bar is subject to compression on one side and tension on the opposite side. This causes a significant bond force transfer between the concrete and longitudinal steel. The loss of bond changes the compressive stress in steel to tensile stress [4, 5]. As a result, the compressive force is increased to equilibrate the increased tension. Hence, it leads to a question whether the bond deterioration accelerates the crushing of the diagonal concrete strut. This paper attempts to investigate this problem by testing a beam-column joint with completely no bond between longitudinal bar and concrete in the joint. The result is compared with the control specimen where full bonding is provided. Another objective is to study the performance of substandard interior beam-column connection constructed in Thailand.

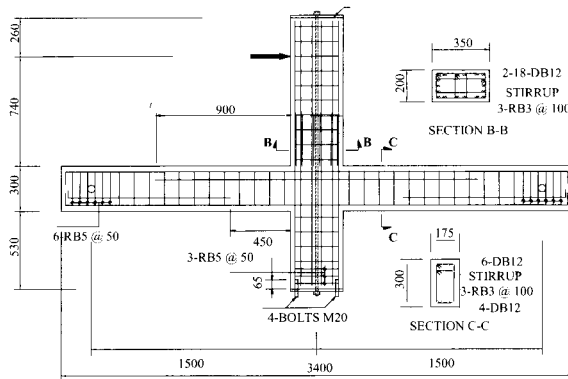
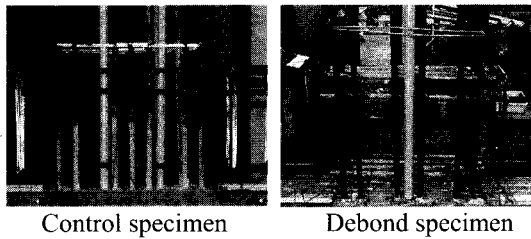
**Figure 2** Specimen dimension and reinforcement detail

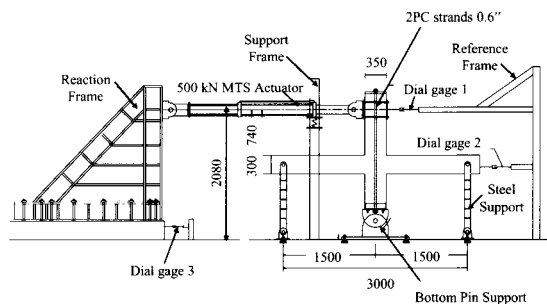
**Figure 3** Test set-up

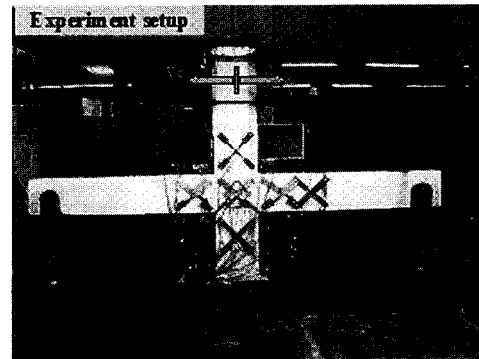
**Figure 4** Photo of specimen set-up in laboratory

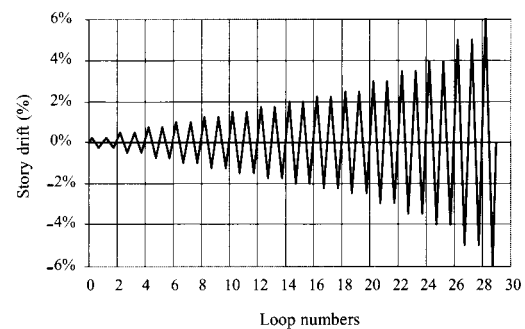
**Figure 5** Load patterns

The load applied to the specimen was lateral cyclic displacement-controlled. The column was pushed and pulled with increasing interstory drift of  $\pm 0.25\%$ ,  $\pm 0.5\%$ ,  $\pm 0.75\%$ ,  $\pm 1\%$  and so on as shown in Figure 5. At each drift level, the displacement was repeated twice to check the stability of the loop as well as to investigate the energy dissipation.

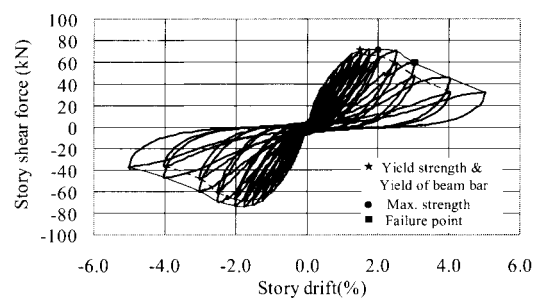
Figure 8 Story shear-story drift relation of the control specimen

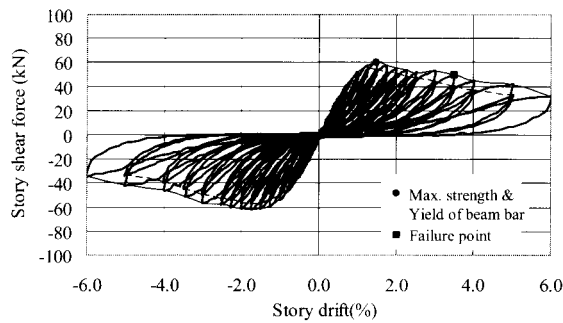
**Figure 9** Story shear-story drift relation of the debond specimen

of 62 kN at 1.5% drift. However, the drop of peak load was not as sudden as that of the control specimen. It was supposed that the gradual reduction of peak load was caused by a gradual reduction of moment arm due to loss of the concrete compression zone on the beam's cross section. Similar to the control specimen, the repeated cycle at the drift beyond peak was unstable, and the loop was narrow with low energy dissipation. At 5% drift, the residual strength of specimen was 67% of the peak value.

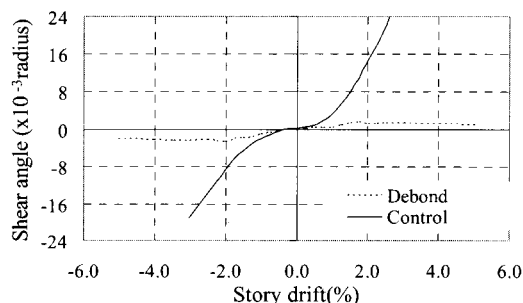
**Figure 10** Comparison of joint shear angle-story drift relation

The relation between joint shear deformation and story drift is compared between the control and debond specimen as shown in **Fig. 10**. It is seen that the joint deformation of the debond specimen is substantially lower than that of the control specimen. This is because cracks and following nonlinearity are mainly concentrated around the beam ends due to a pull-out effect. As shown in the **Fig. 11**, the column of the debond specimen was displaced laterally while the beam remained straight. This suggests that a substantial rotation must occur at the beam-joint interface due to concrete spalling and bar pull-out. The total lateral top column displacement is compatible with this interface localized rotation while the joint deformation is very small. In contrast, diagonal cracks are mainly concentrated at the joint core of the control specimen, giving rise to significant damage of concrete core resisting diagonal compression. It may be concluded that the joint shear

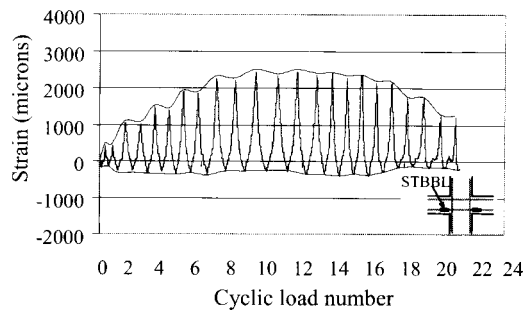
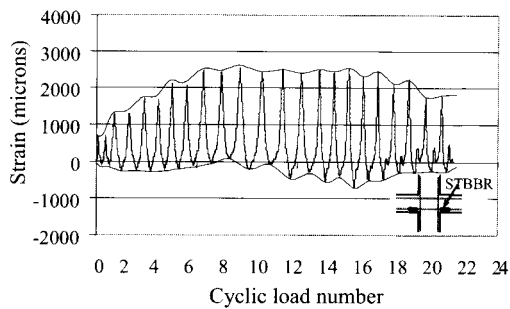
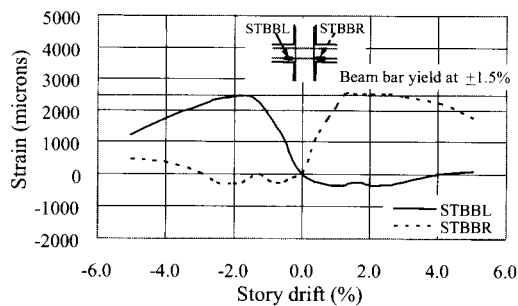
(a) Strain of beam bar at left side

(b) Strain of beam bar at right side.

**Figure 13** Strain envelope of the control specimen

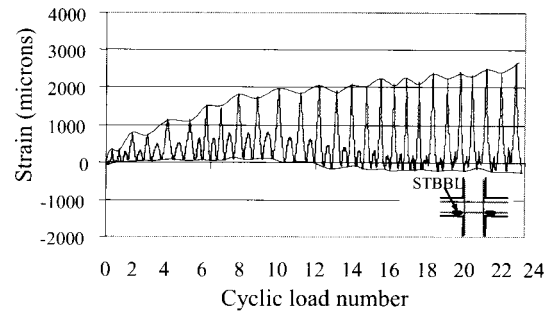
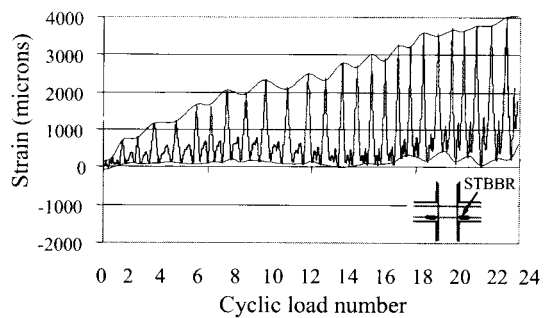
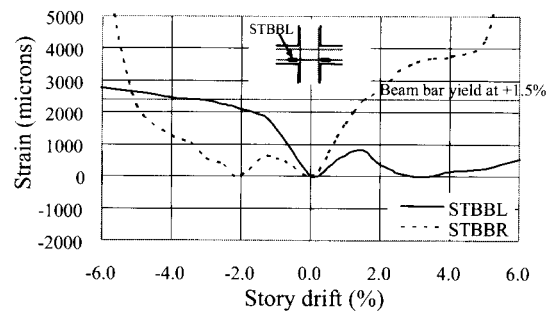
(a) Strain of beam bar at left side

(b) Strain of beam bar at right side

**Figure 15** Strain envelope of the debond specimen

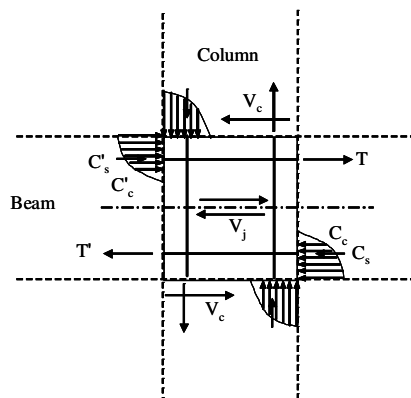
Figure 1. Horizontal shear force in joint core.

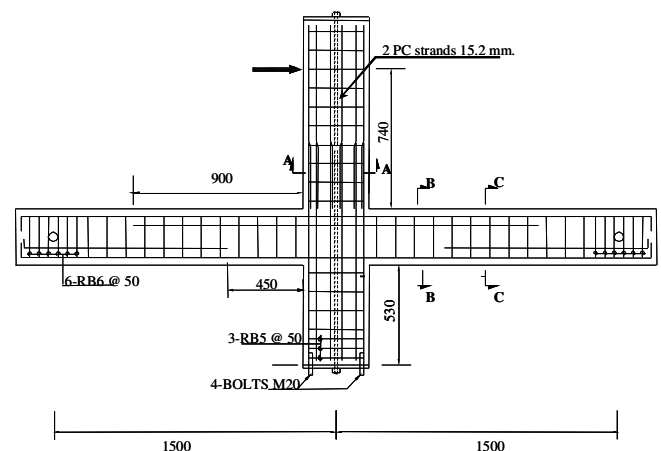
Figure 3. Geometry, dimension and reinforcement of all specimens (unit:mm)

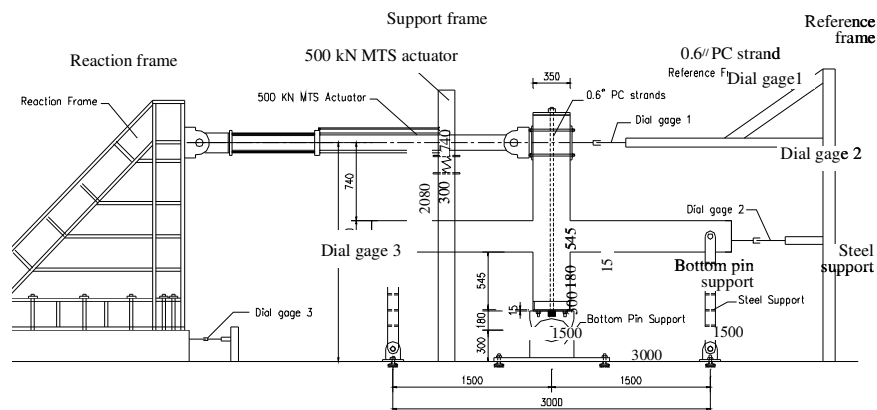
Figure 5. Test set-up

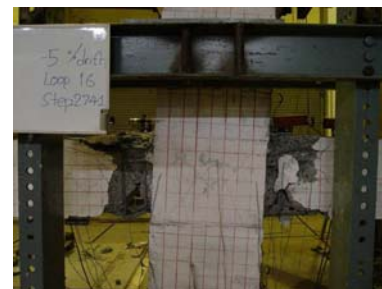
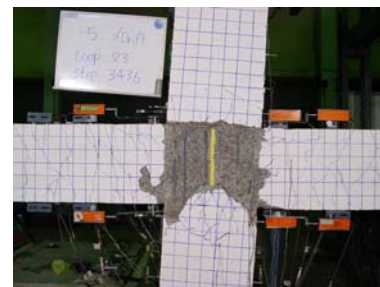
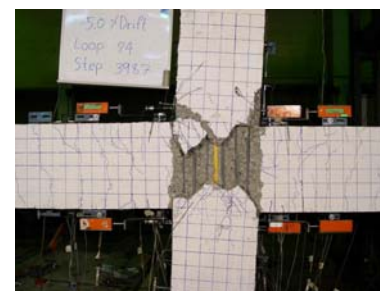
(a) Failure of specimen JL

(b) Failure of specimen JM

(c) Failure of specimen JS

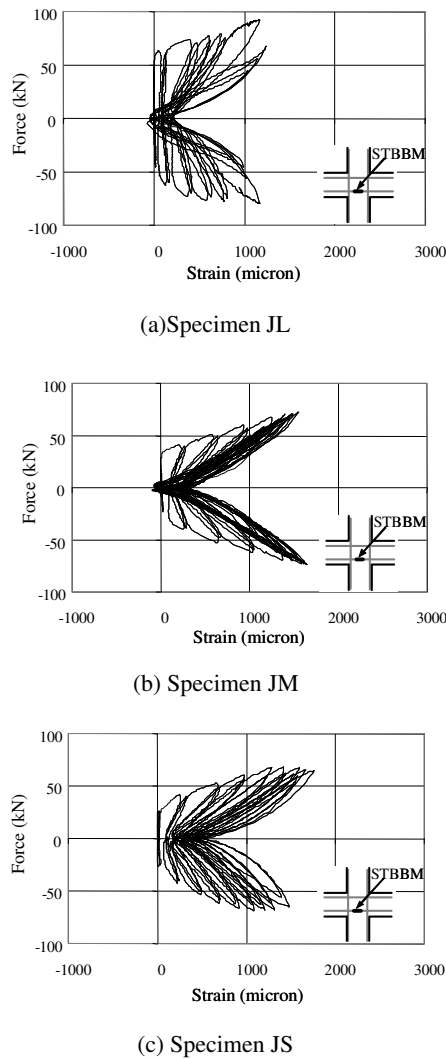
Figure 11. Strain of bottom beam bar (STBBM) at the middle of joint

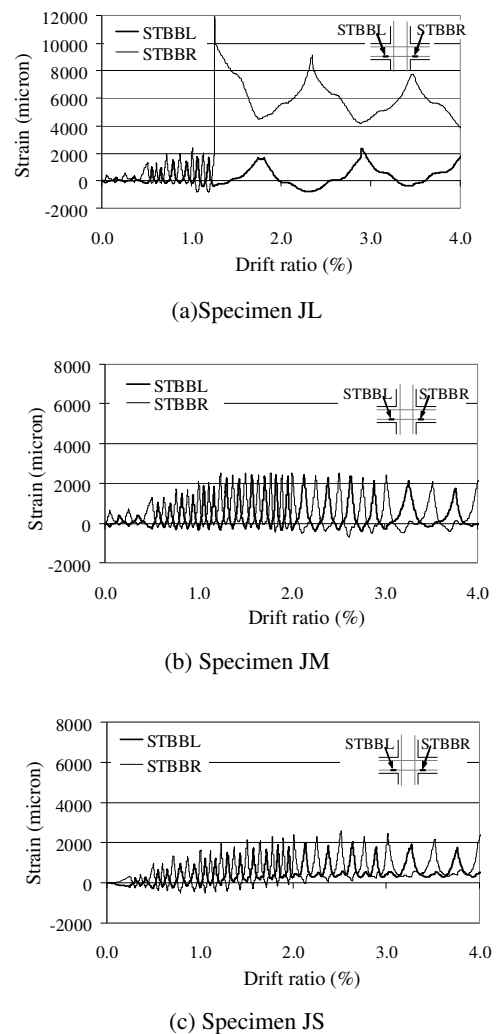
Figure 12. Strain history of bottom beam bar at 50 mm away from the joint fac
