## รายงานวิจัยฉบับสมบูรณ์

โครงการการตรวจสอบและเตรียมความพร้อมโรงพยาบาลใน  
พื้นที่เสี่ยงภัยแผ่นดินไหว: บทเรียนจากแผ่นดินไหวแม่ลาว

โดย...ธีรพันธ์ อรรถธรรมรัตน์

มหาวิทยาลัยมหิดล

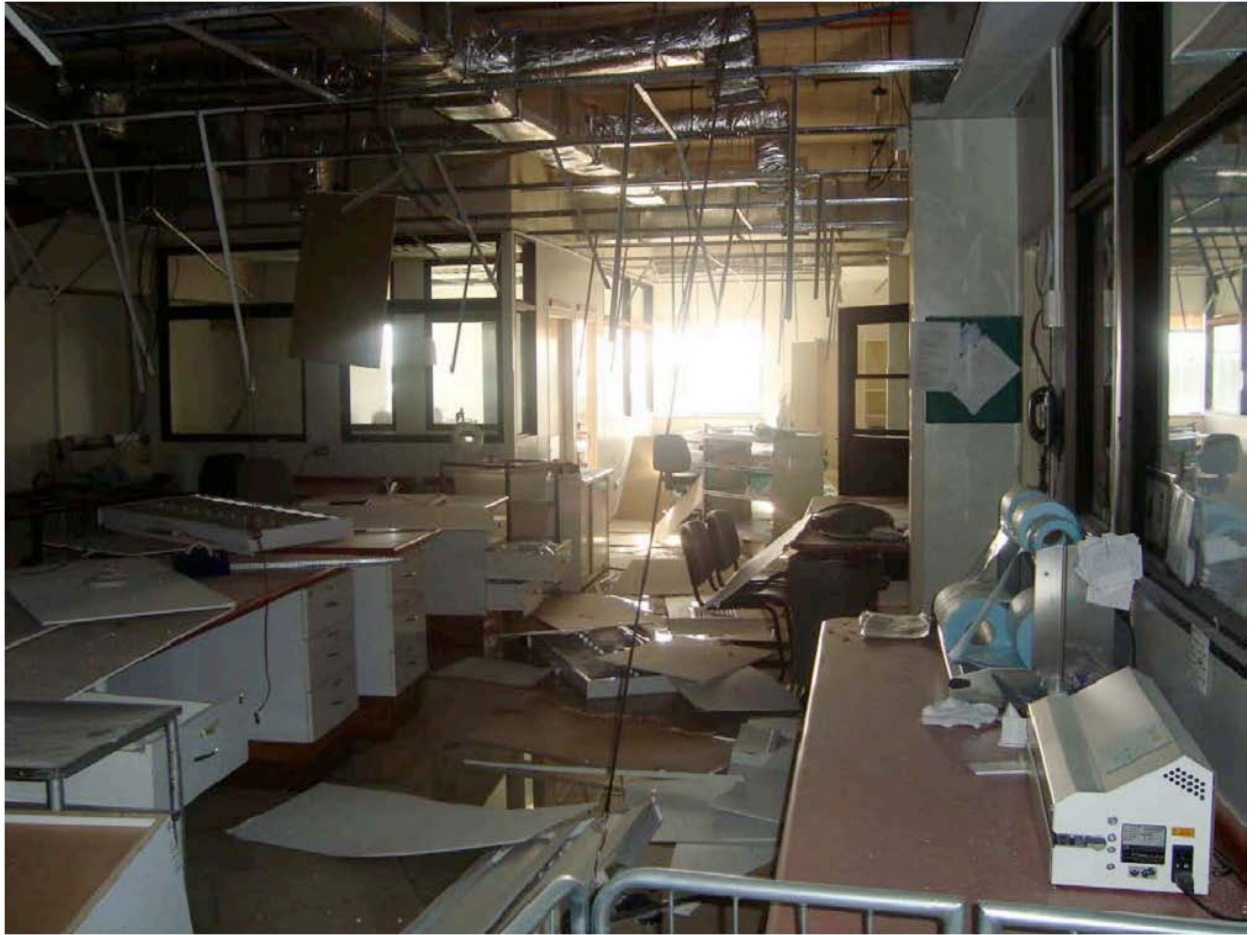
รูปที่ 5 สภาพความเสียหายของฝ้าเพดาน และ ระบบหลอดไฟฟ้า และ ระบบระบายอากาศที่โรงพยาบาล Los Angeles เนื่องจากแผ่นดินไหวขนาด 8.8 ที่ประเทศชิลีเมื่อปี พ.ศ. 2553

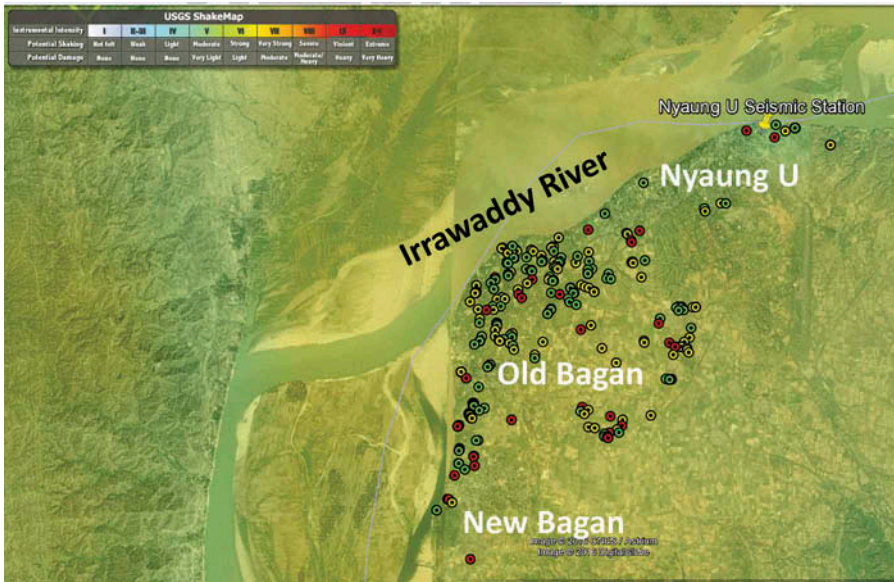
From [Table 1](#), it is quite clear that the heaviest damaged historical monuments are, as expected, large and medium monuments (base width greater than 12 m). Out of 2,000 ancient monuments in Bagan, 50 of them (2.5%) are classified as heavy damage (red class). In contrast to 1975 event, there is no report of collapsed pagoda from 2016 Chuak earthquake. In addition, [Fig. 4](#) displays spatial distribution of damaged pagoda (red, yellow, and green tags), and it could be noticed that the distribution of red and yellow tag pagodas in Old Bagan area uniformly distributed and extend entirely across the city, from Irrawaddy River to the north into the flat plain in the south. Plotting the tags on [Fig. 4](#) is also overlaid by ShakeMap of the August 24, 2016 mainshock, and the MMI V has been assigned to the entire Bagan and Nyaung U area. In addition, microtremor analysis

**Figure 4.** Spatial distribution of damaged pagodas (green, yellow, and red tag) from Mw 6.8 earthquake on August 24, 2016 following structural assessment by Myanmar Earthquake Committee (MEC). Nyaung U seismic station is located at the top right corner.

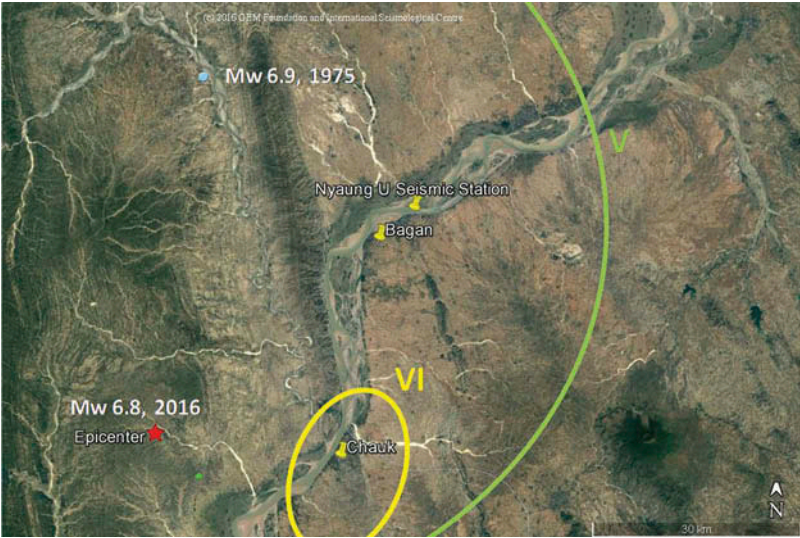
**Figure 12.** Iseismal map for the Mw 6.8 Chauk earthquake of August 24, 2016, 10:34 UTC. Contour intensity lines had been drawn according to observed damage from this field survey.

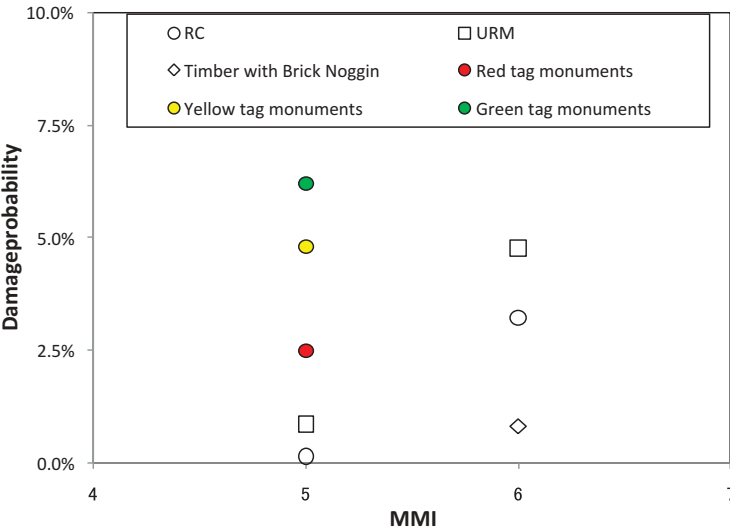
parameters that were derived and used to construct the seismic fragility curve in this study are summarized in Table 4. Due to limited damage in Bagan and Nyaung U, only damage statistic of 2 structural types could be able to develop seismic fragility curve, i.e, URM and RC buildings. Figure 13 illustrates the fragility curves for URM and RC buildings constructed in epicentral area. In addition, damage probabilities of three damage levels of historical monuments in Bagan (Table 1) were also shown. The main findings of this study and their applicability are summarized as below.

Figure 13. Damage probability of light damage level for different existing structures and monuments against MMI for Bagan, Nyaung U, and Chauk with different building types.
